# Utah State Prison Relocation Site - West

## Phase I Environmental Site Assessment

**November 2015**

**LOCHNER**

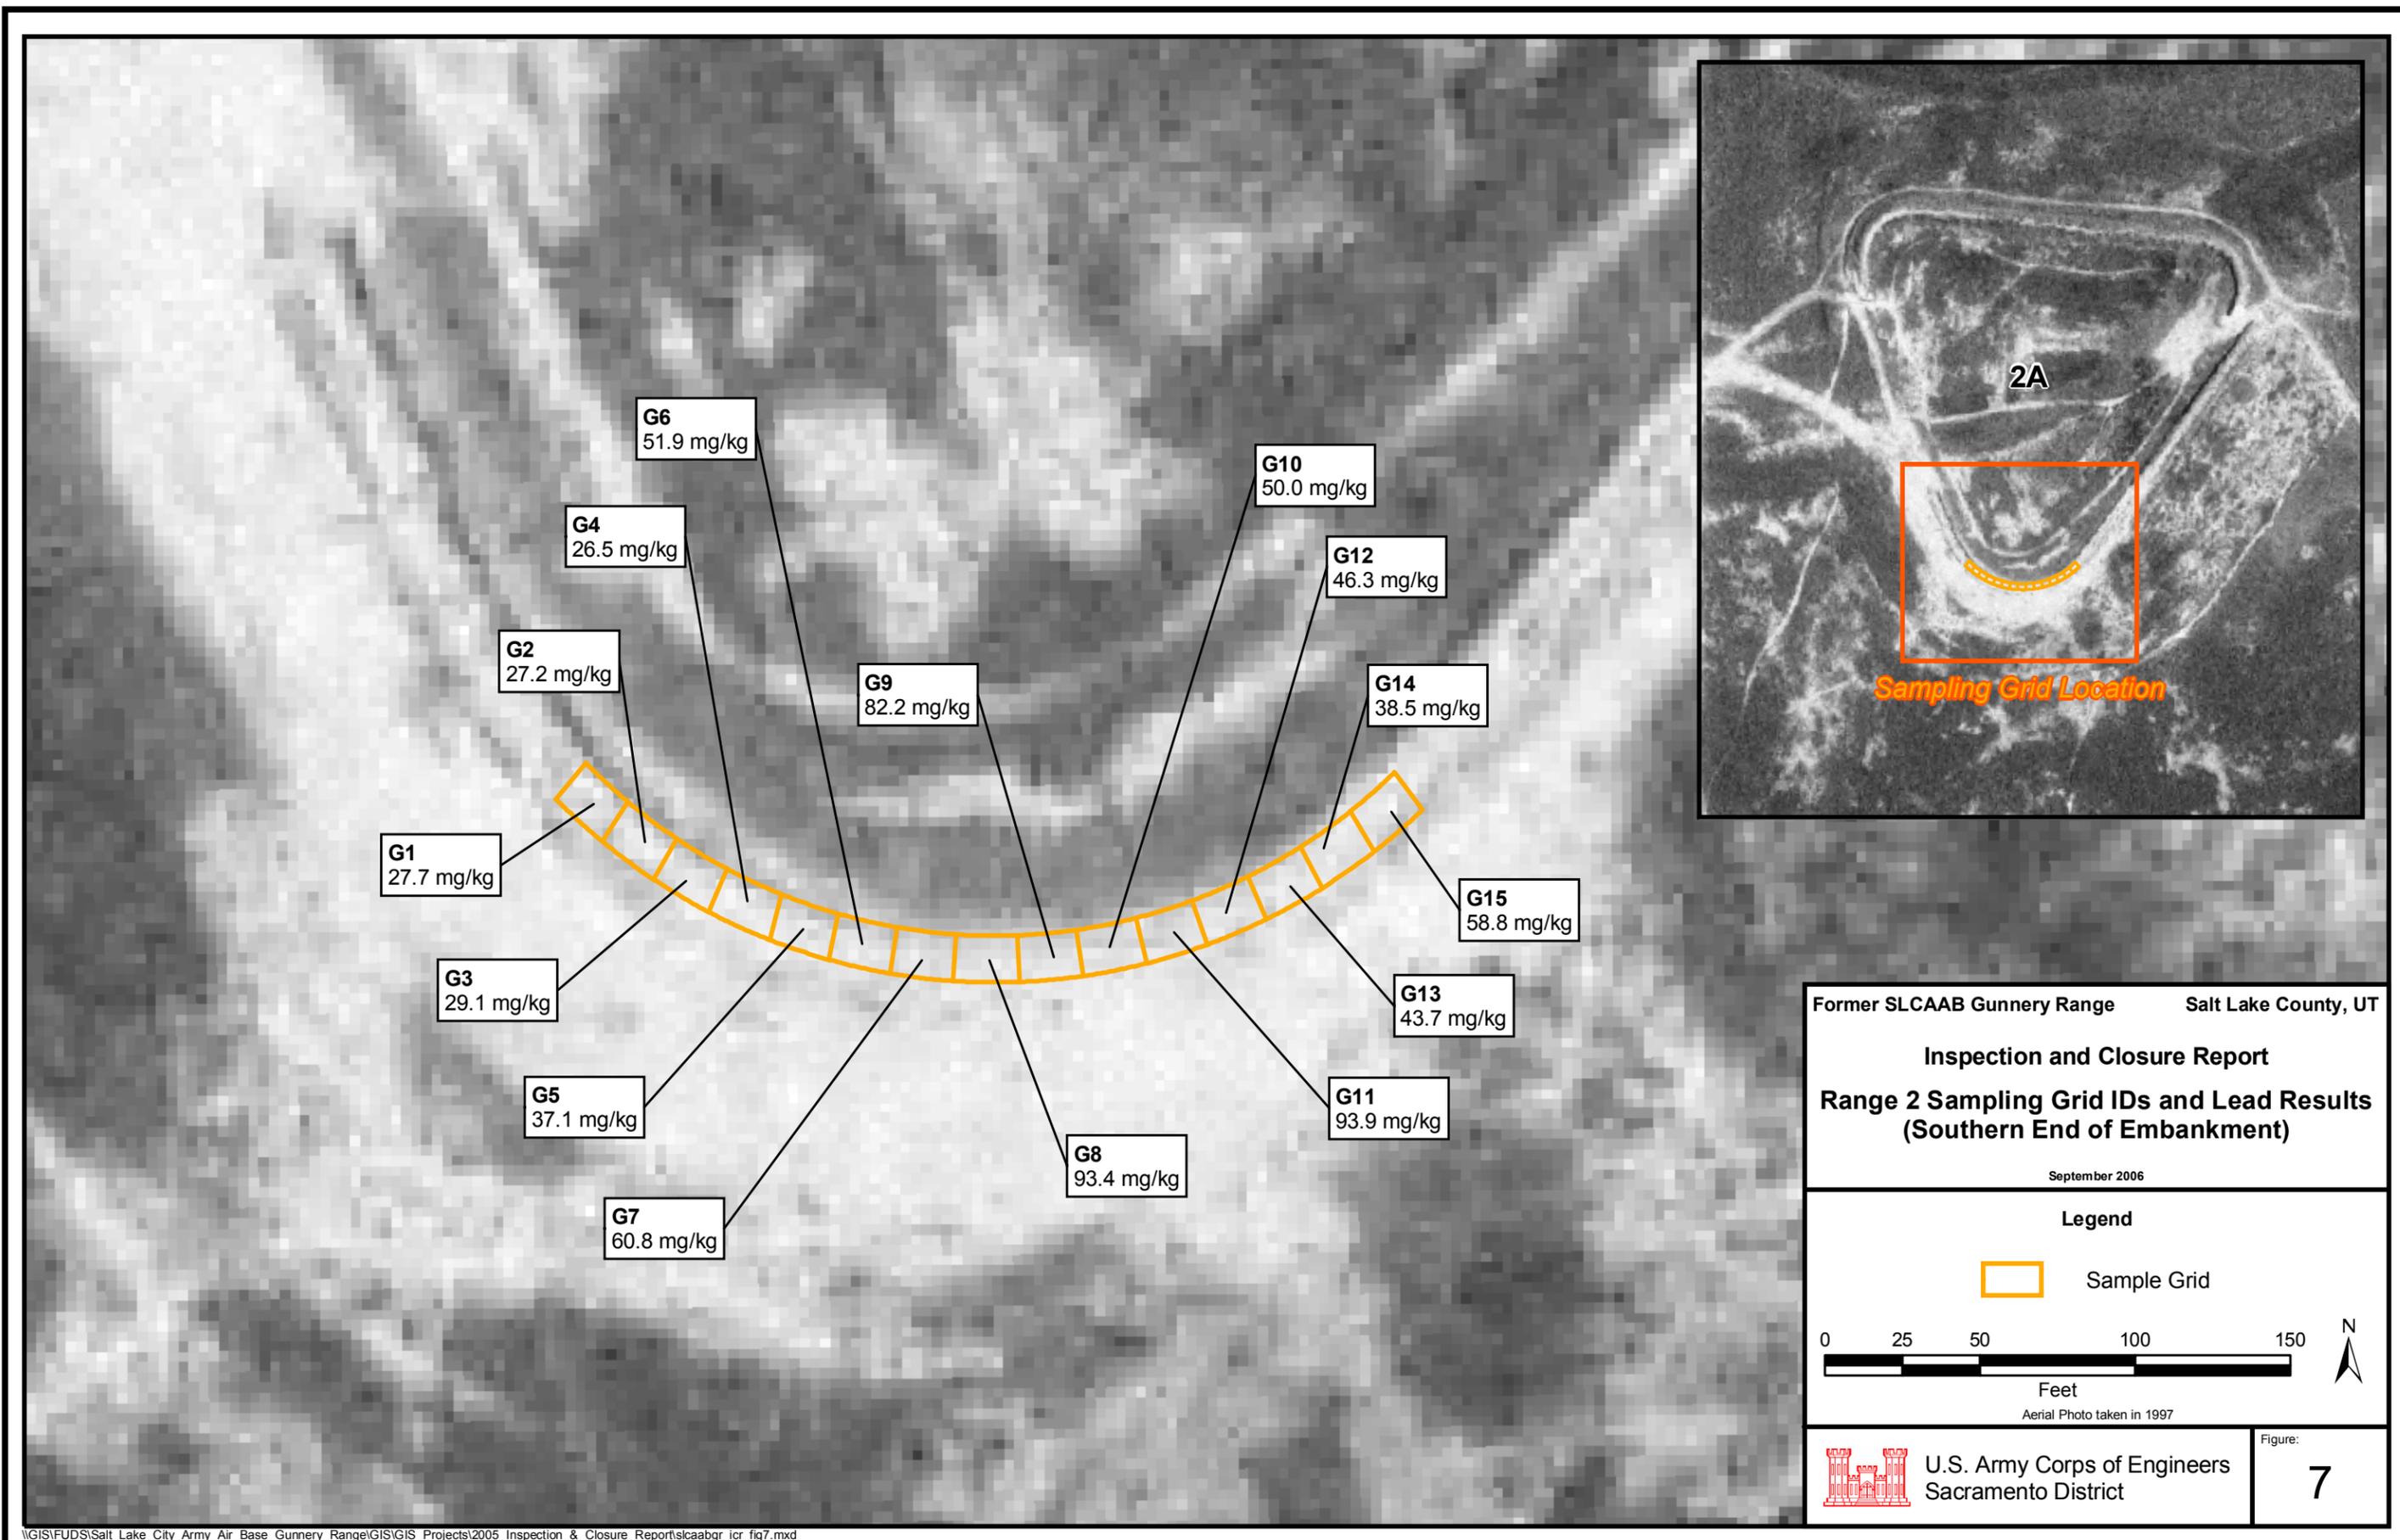
**Inspection and Closure Report**  
**Range 2 Sampling Grid IDs and Lead Results**  
**(Southern End of Embankment)**

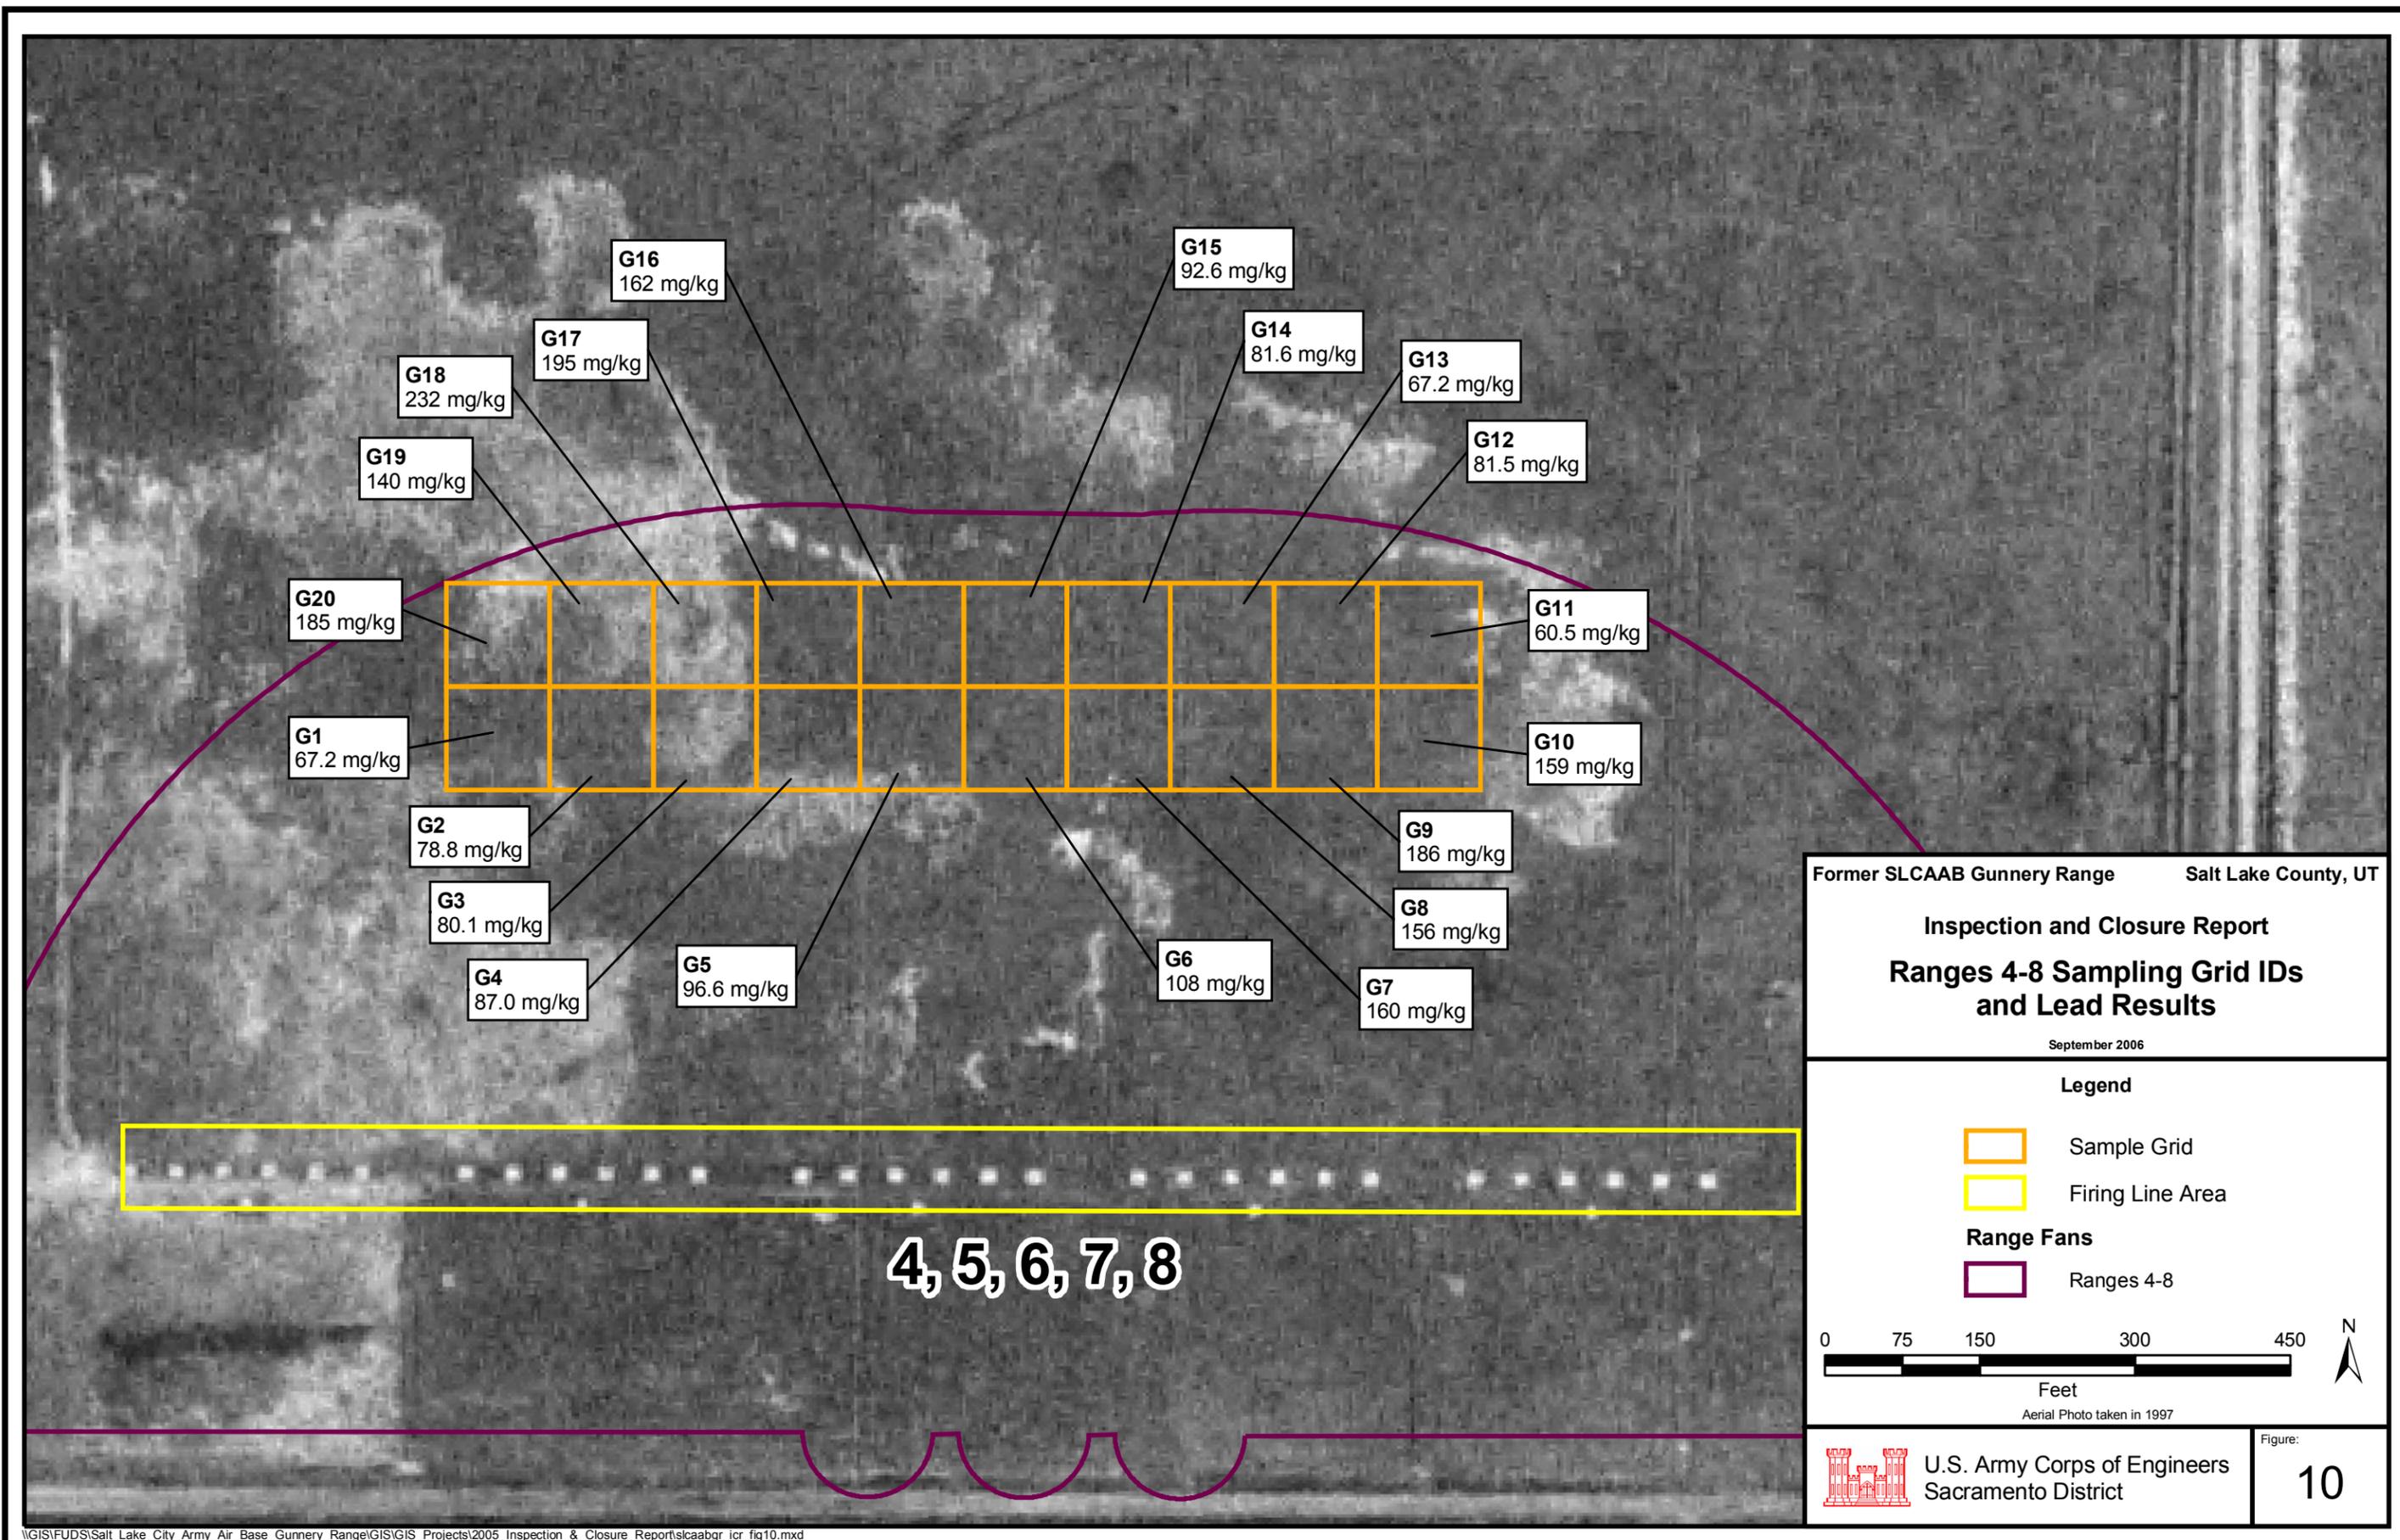
**Inspection and Closure Report**  
**Ranges 4-8 Sampling Grid IDs and Lead Results**

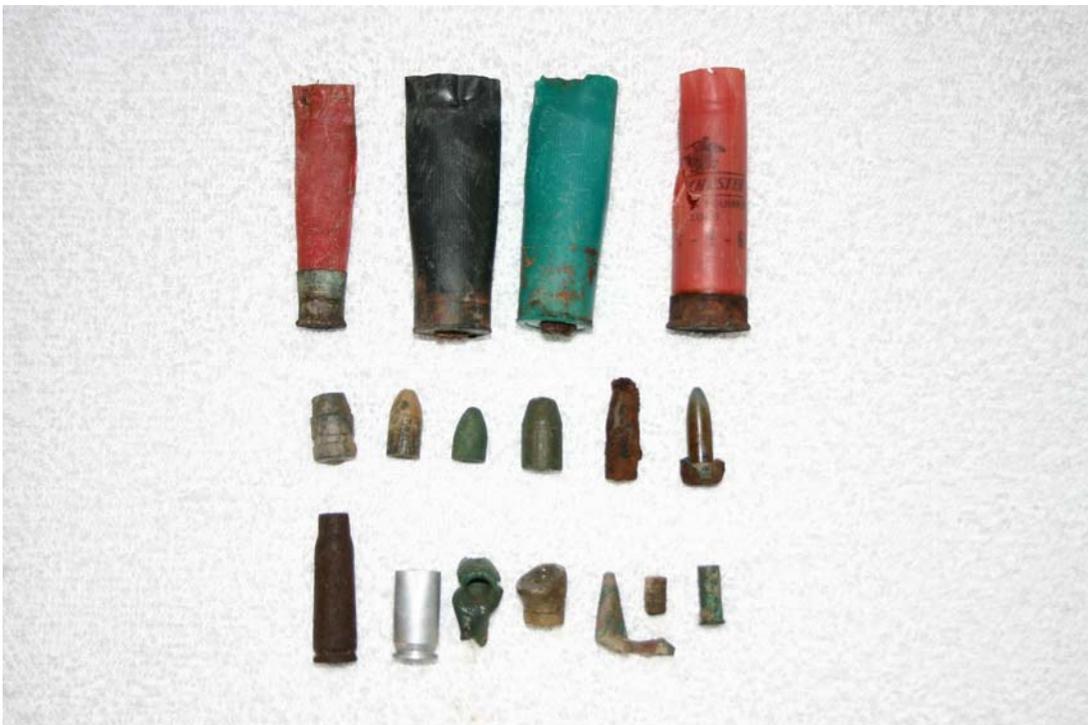
Range 2 – Non-DoD target debris, interior of the embankment, May 2004

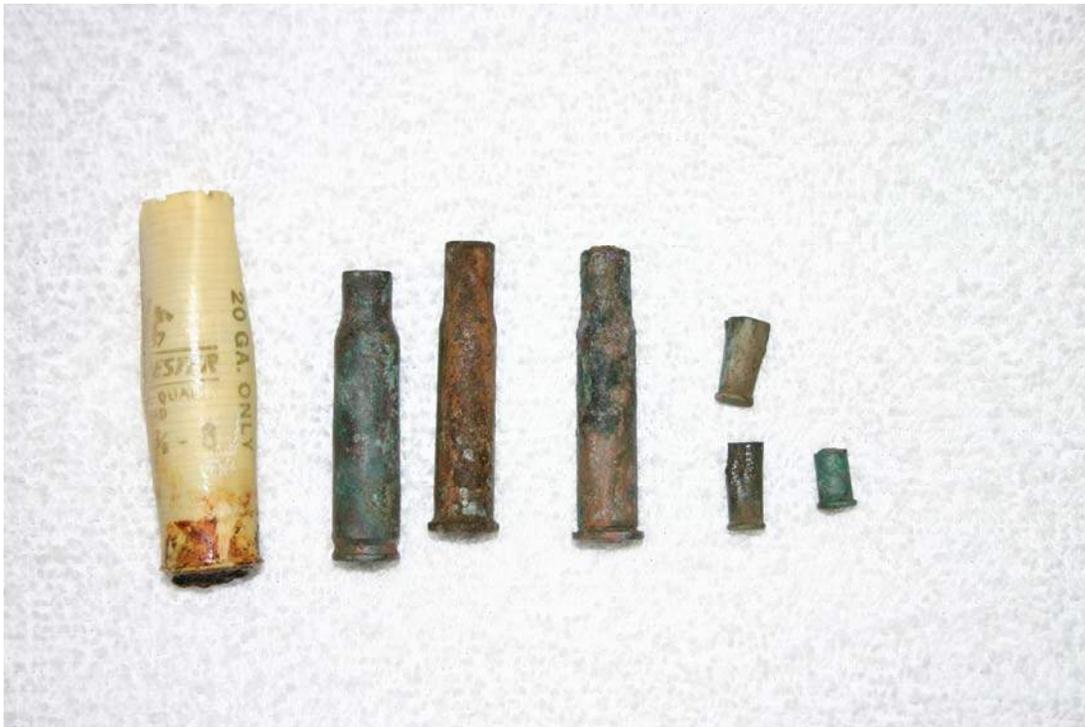
Range 2 – Typical spent munititions found on the interior portion of the northern wall of the earthen embankment, May 2004

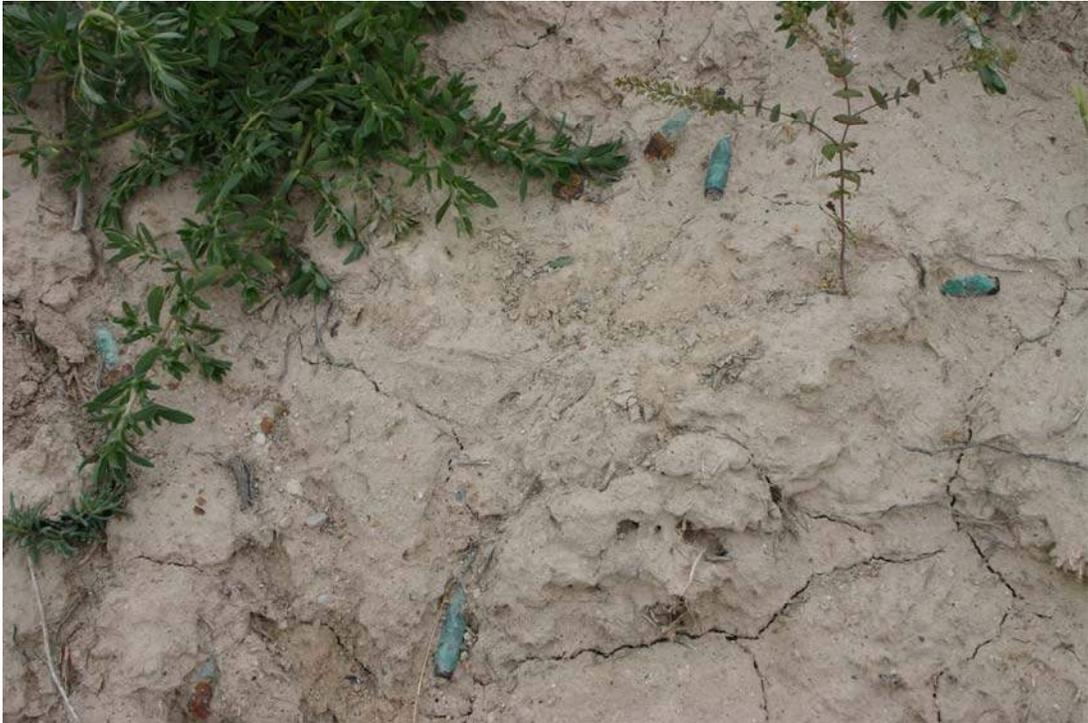
Range 3 - Spent shotgun shells found on the interior portion of the northern wall of the earthen embankment, May 2004

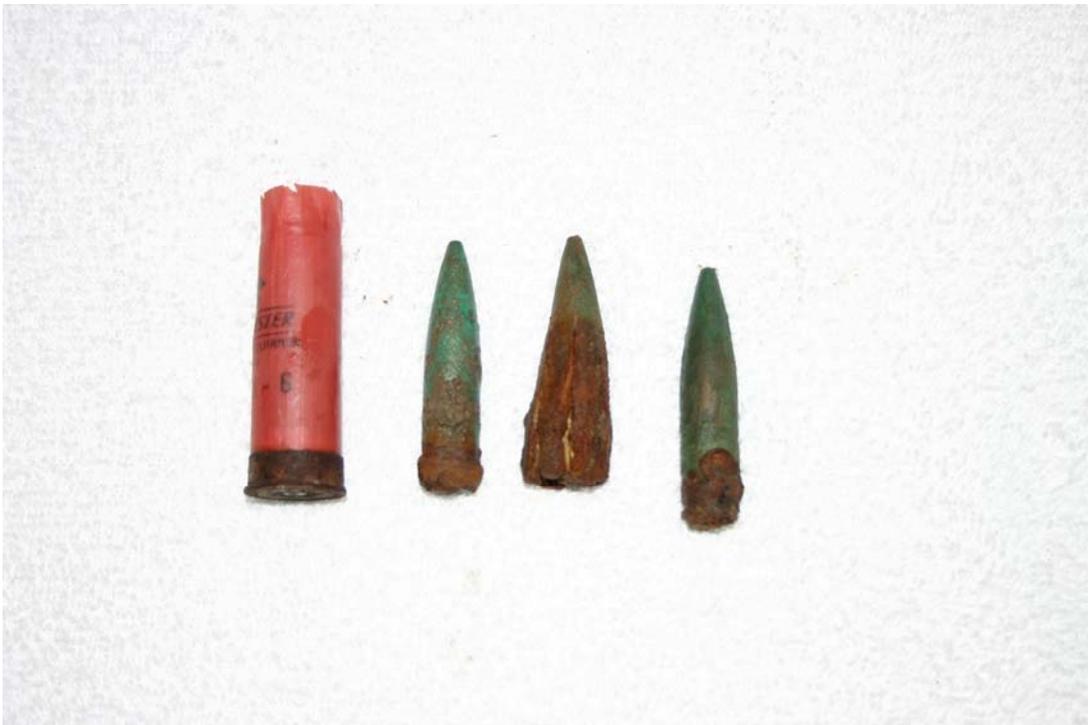
Range 3 - .50 caliber rounds embedded in the interior portion of the northern wall of the earthen embankment, May 2004

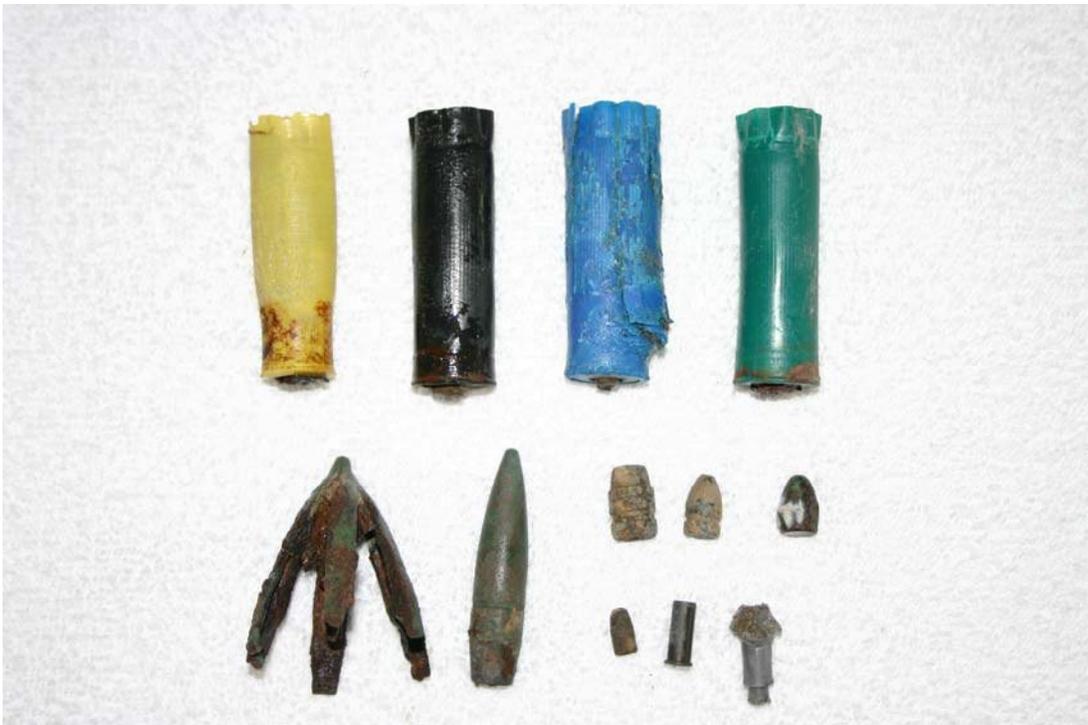
Range 3 – Non-DoD target debris, inside face of northern wall of embankment,  
May 2004

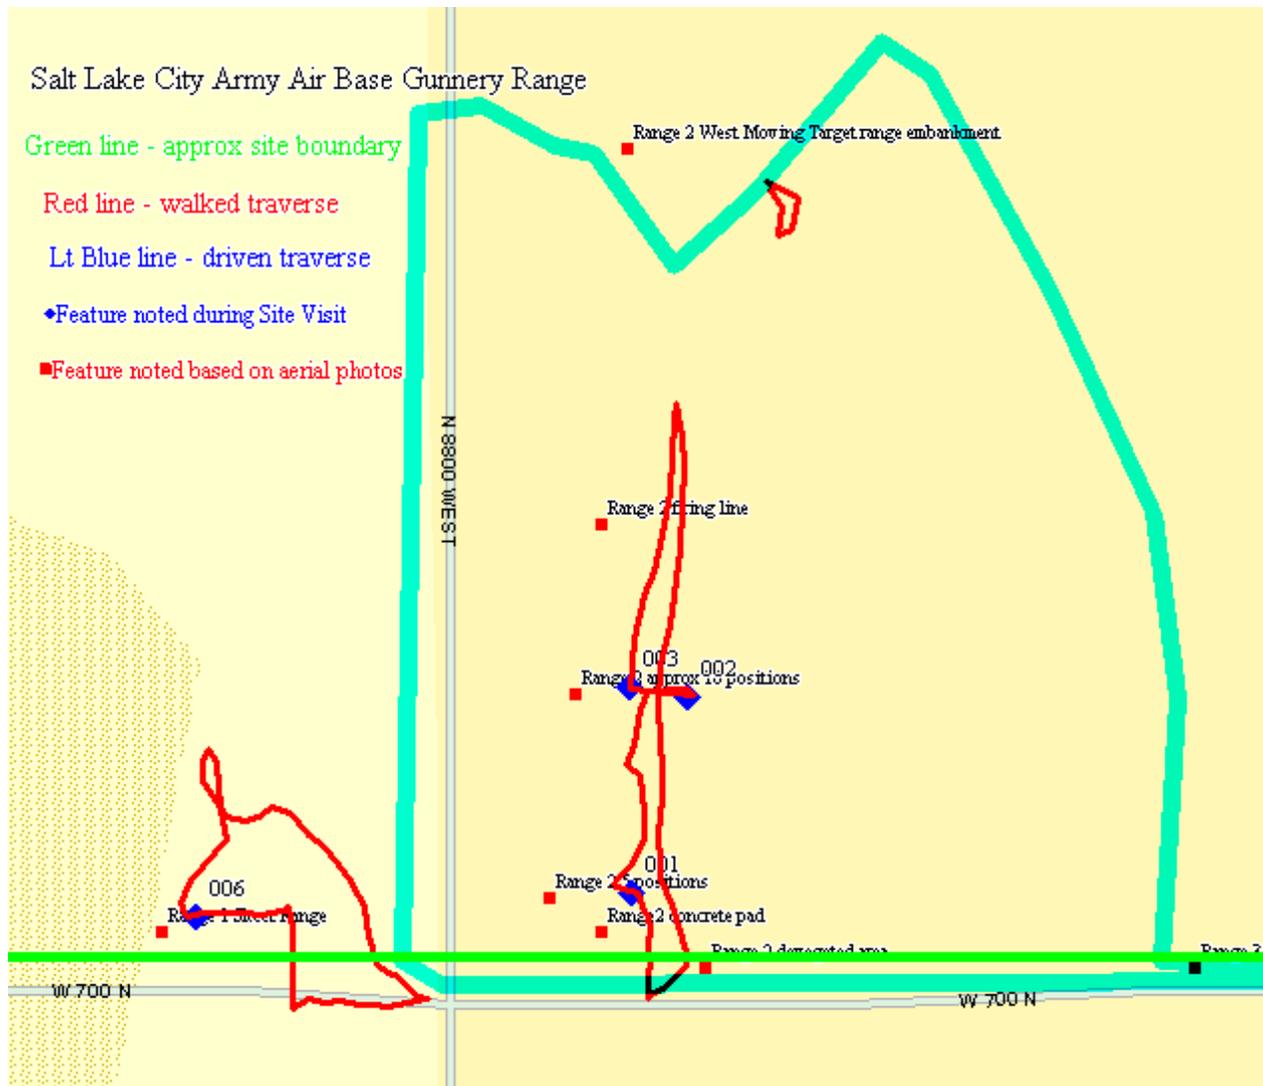
The site inspection team gathered shortly after 0800 and traveled to the moving target (jeep type) ranges portion of the site belonging to the Bothwell Swaner landowners represented by the attorneys. At the embankment of the west jeep range (i.e. Range 2), the inspection team discussed the status of the site. Except for the St. Louis District, elements of the other groups present had visited the site previously and reported finding .50 caliber projectiles during those visits. The attorneys noted that the landowners were considering developing the area as a mixed use residential, commercial and light industrial community in the foreseeable future. In the last few years, the State of Utah conducted some lead sampling on the southern edges of the earth embankments and selected areas around the property with the highest concentration found on the south end of the east embankment. The upper portion of the south end and all the western portion of the west embankment had been removed for use as road fill on property to the east a couple years earlier.

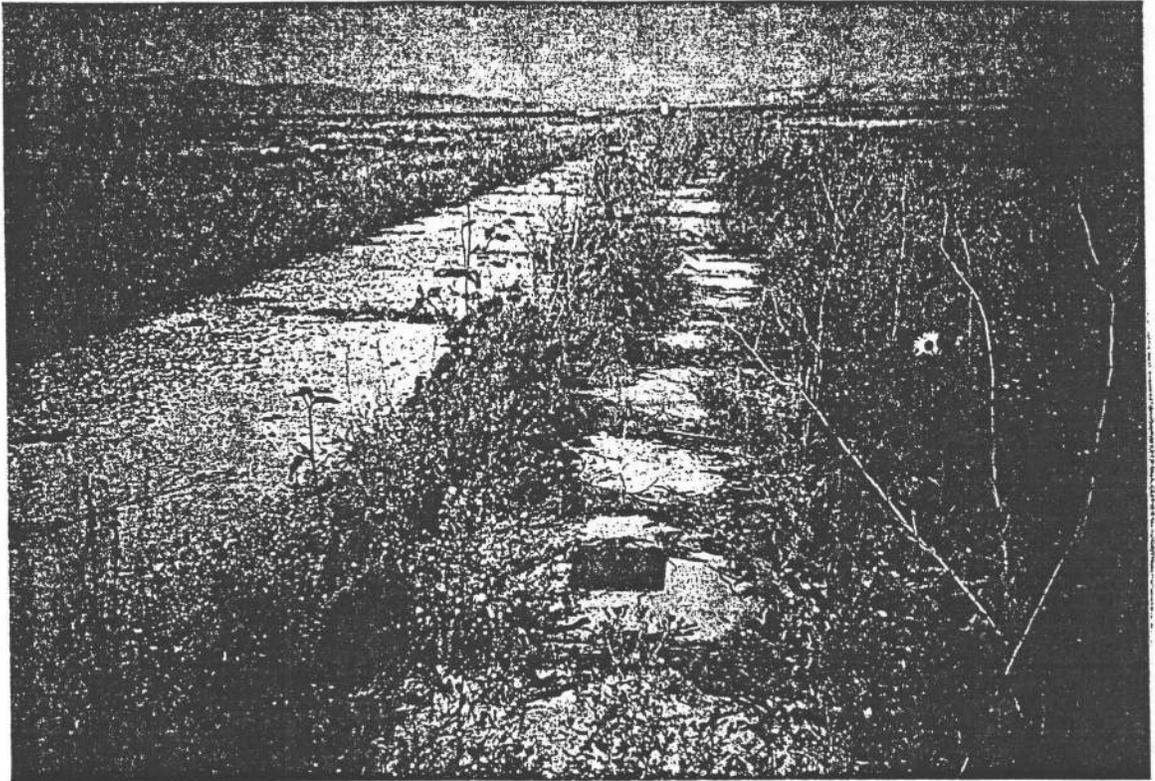
PHOTO 1: View to the west. View is of the long concrete foundations used to hold gun mounts during testing, approximately 250 feet long (east-west) by 15 feet across. In foreground is a metal gun mount (12" X 12").

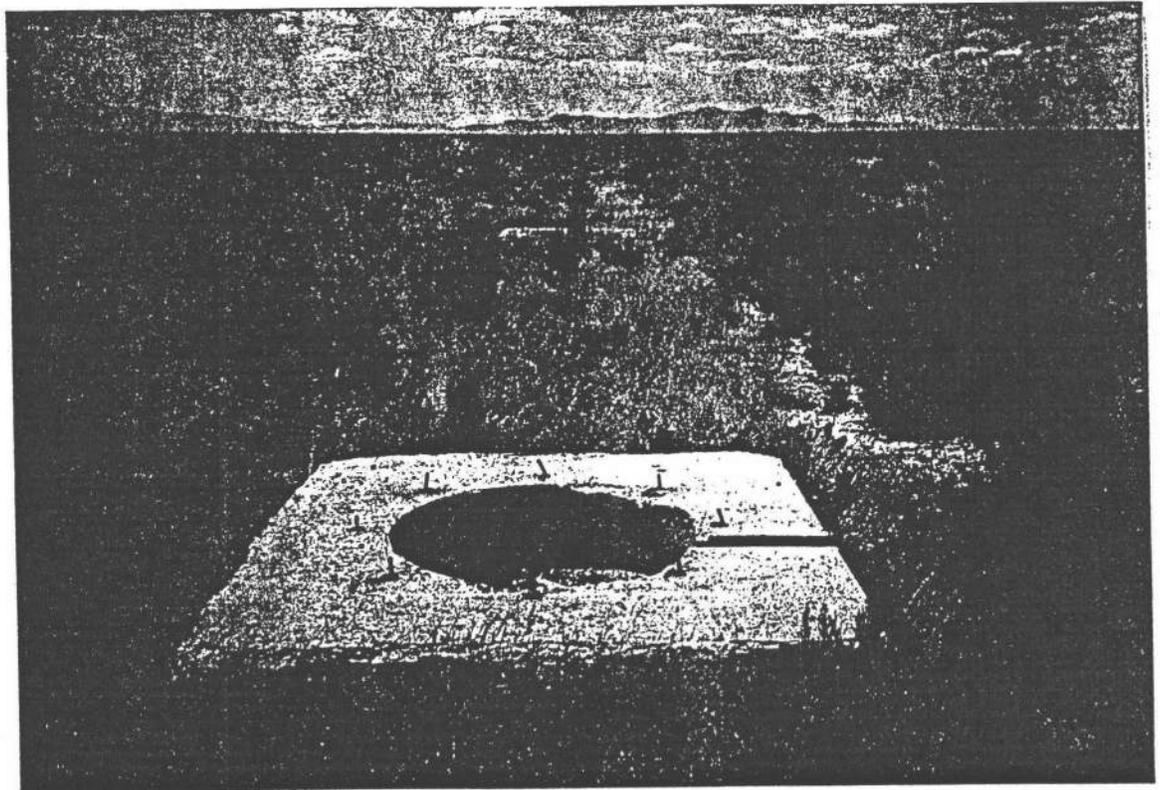
PHOTO 12: South of berms. One of five such foundations: 5' X 5', with 3' diameter hole (1' deep). From USACE 1992 report (Figure 3 area).

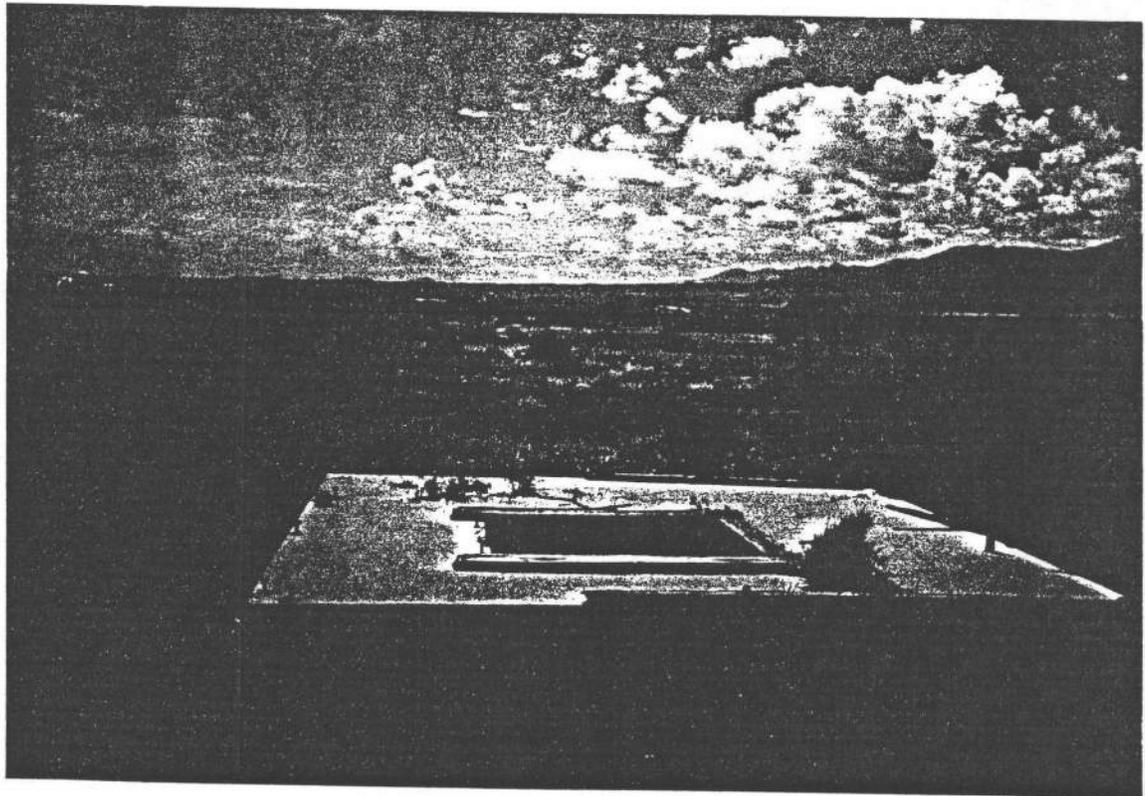
PHOTO 14: 12' X 12' concrete foundation, with pit in middle 4'X8'X4' deep. From USACE report (Figure 6 area).

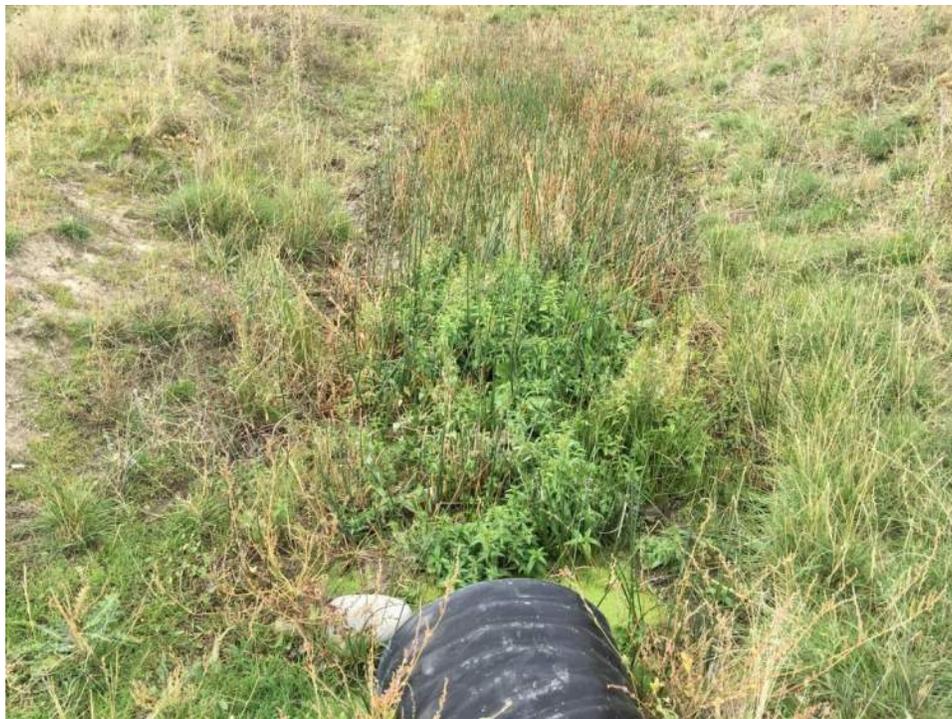
**Photograph 19:** Ponding water near North Point Consolidated Canal looking west. Water source appears to be from the canal or from two ponds on the adjacent property. It does not appear that the source is a hazardous waste producer (Viewpoint 6 on Figure 1).

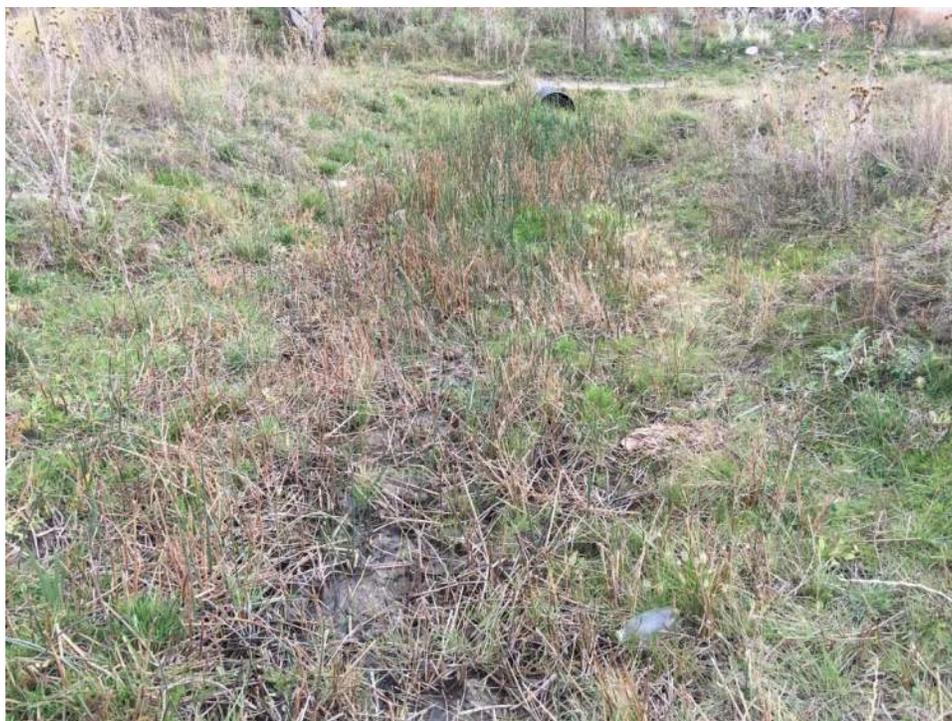
**Photograph 20:** Ponding water near North Point Consolidated Canal looking east (Viewpoint 6 on Figure 1).
