WATERS OF THE U.S. AND WETLAND
DELINEATION REPORT

UTAH STATE CORRECTIONS
FACILITY RELOCATION

PREPARED IN ACCORDANCE WITH:
1987 CORPS OF ENGINEERS WETLAND
DELINEATION MANUAL &
ARID WEST REGIONAL SUPPLEMENT

NOVEMBER 2015

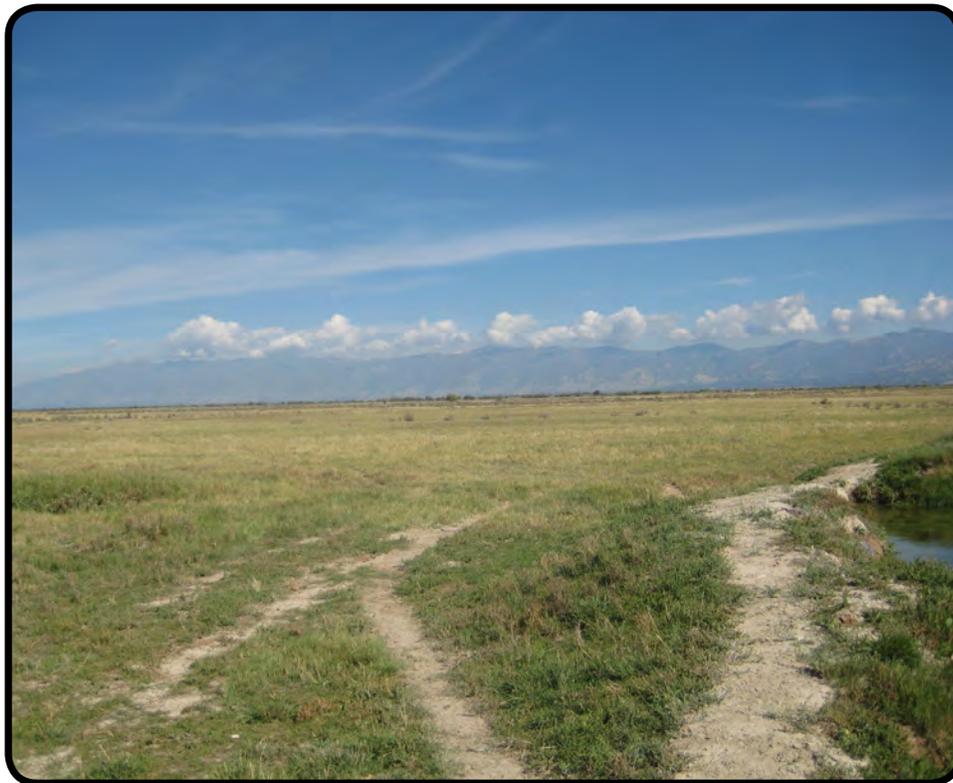
Photo 1 - General Conditions Observed within the Delineation Study Area

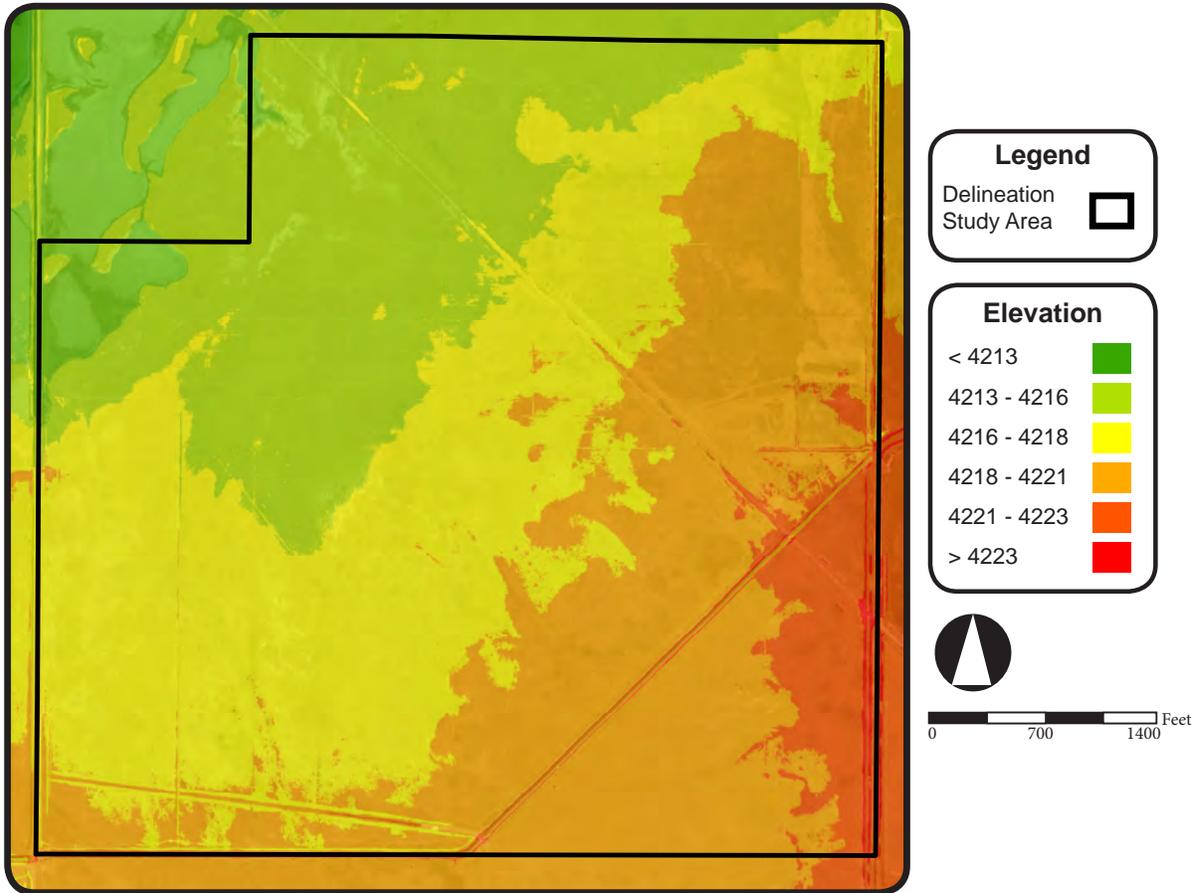
The delineation study area is located within the Salt Deserts subregion of the greater Central Basin and Range ecoregion near the southern shore of the Great Salt Lake (USEPA 2015). The site has an average annual precipitation of 16 inches. The topography of the delineation study area gently slopes from the southeast corner (4,224 feet) to the northwest corner (4,213 feet) (see Figure 2). The site is zoned for agriculture and is currently being used for grazing. More detailed information regarding the site's existing vegetation, soils, and hydrology is included in the sections below.

Figure 2 - General Topographic Conditions within the Delineation Study Area

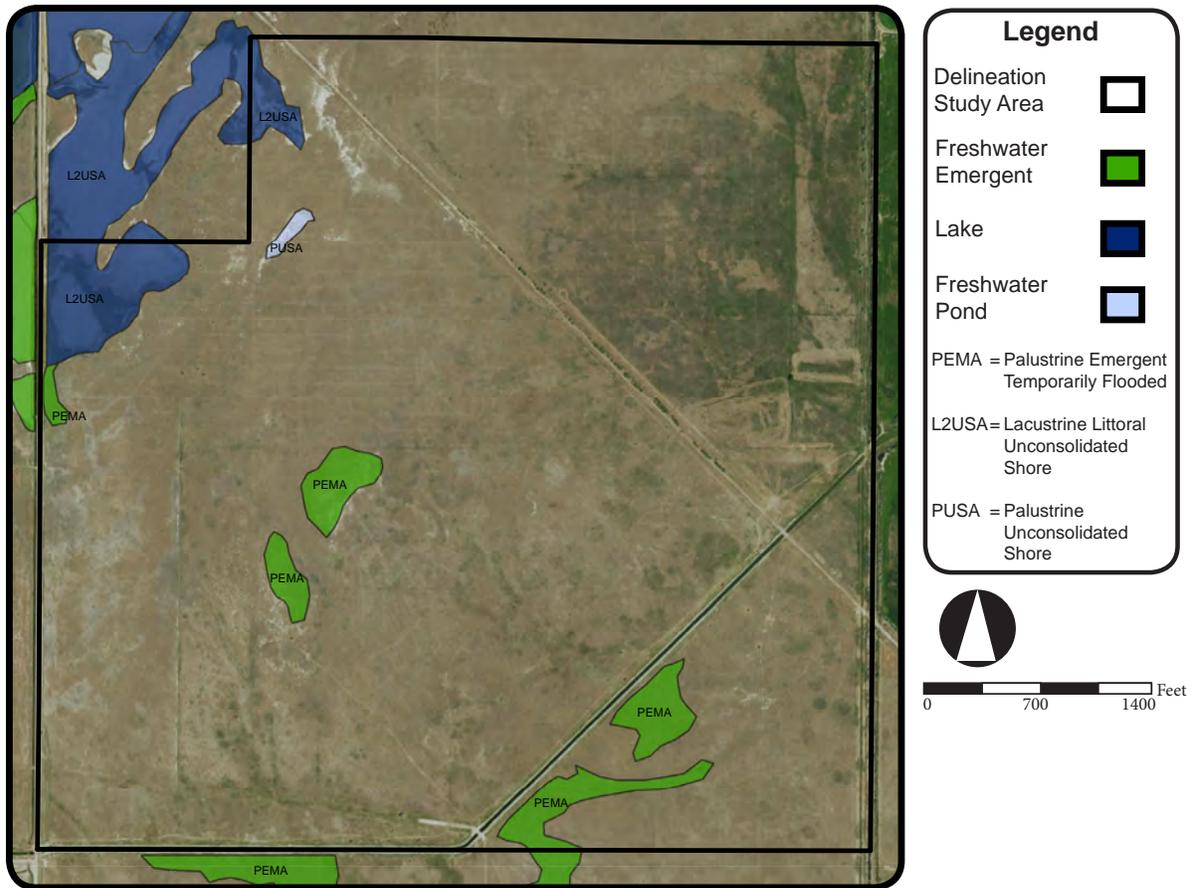
National Wetlands Inventory (NWI) data was obtained from U.S. Fish and Wildlife Service which shows potential wetlands within the delineation study area (USFWS 2015). See Figure 3. NWI data does not necessarily reflect conditions on site, so each feature identified on the NWI map was surveyed extensively to determine if the area met all three wetland parameters (vegetation, soils, and hydrology) necessary for classification as a wetland. For delineation results refer to Section 4.0 and Figure 7.

Figure 3 - U.S. Fish and Wildlife Service National Wetland Inventory Map

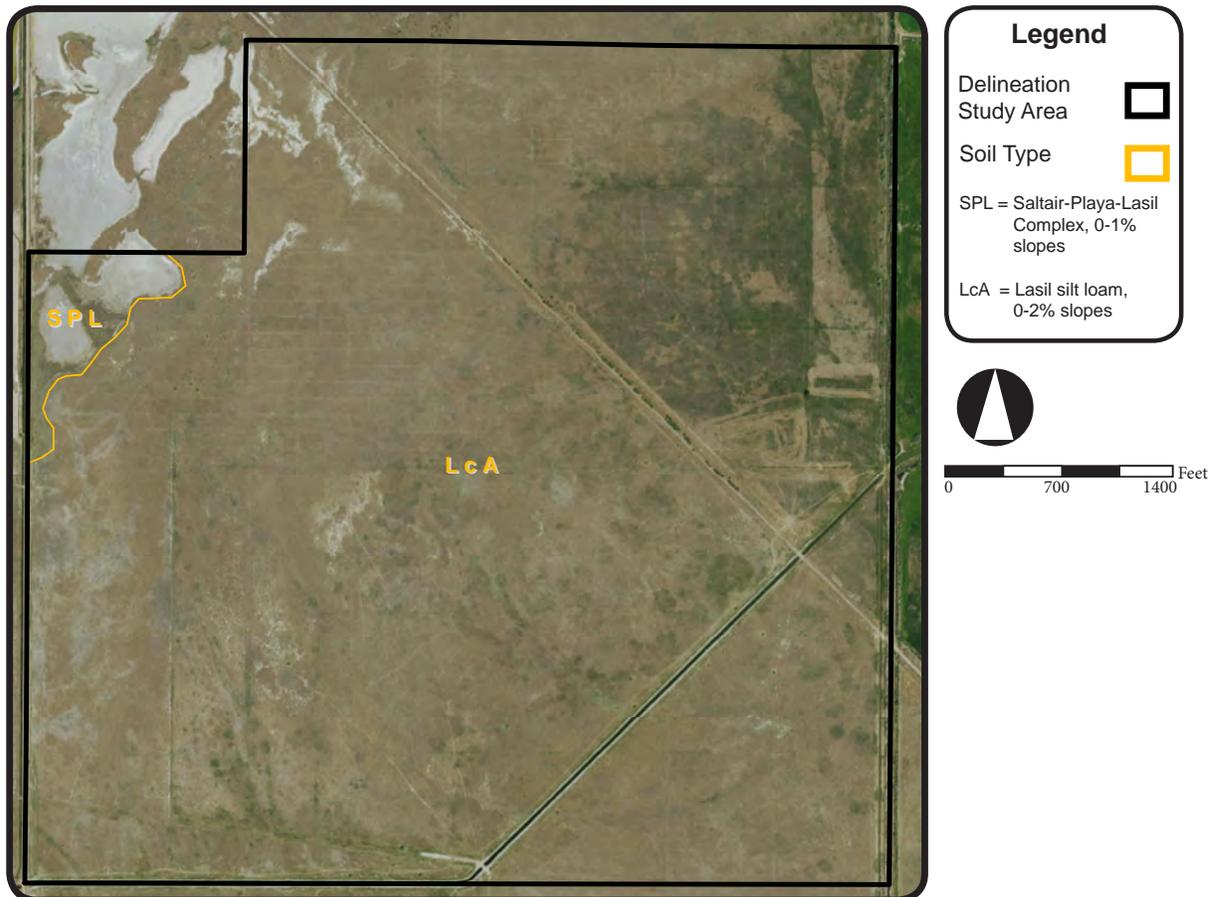
Soil survey information compiled by the National Resources Conservation Service (NRCS) identifies two soil series within the study area (see Figure 4). The Lasil Silt Loam 0-2% Slopes (LcA) series comprises 98 percent of the site and the Saltair-Playa-Lasil Unit (SPL) comprises the remaining 2 percent of the site. The following NRCS soil series descriptions provide general observations whereas the actual site conditions were recorded on the wetland determination data forms.

Figure 4 - Soil Series Found in the Delineation Study Area

The Lasil series is a saline-alkali affected soil that is somewhat poorly drained with a seasonal high water table of 2.5 to 4.0 feet. These soils are generally located on low lake terraces and lake plains and are formed from calcareous mixed lake sediments originating from both sedimentary and igneous rocks. The Lasil series is typed as Typic Natrixeralfs, which means it is an Alfisol – a mineral soil with clay-enriched subsoil. The suborder name of *xeralf* indicates xeric environmental conditions and the great group root *Natrixeralf* indicates a natric (saline affected) horizon. The Lasil series is not on the National Hydric Soils list (USDA 2015b).

The SPL soils are a complex that consists of 40 percent of the Saltair soil unit, 35 percent of the Playa soil unit, and 20 percent of the Lasil soil unit. The complex is found on historic lake plains (playas) that formed from lacustrine deposits originating from mixed lake sediments. Taxonomy for the Saltair soil series is Typic Aquisalids, or an Aridisol (soil with a salic horizon that has its upper boundary within 4 inches of the soil surface) that experiences continuous to periodic saturation and reduction. The Saltair soil series is included on the National Hydric Soils list (USDA 2015b).

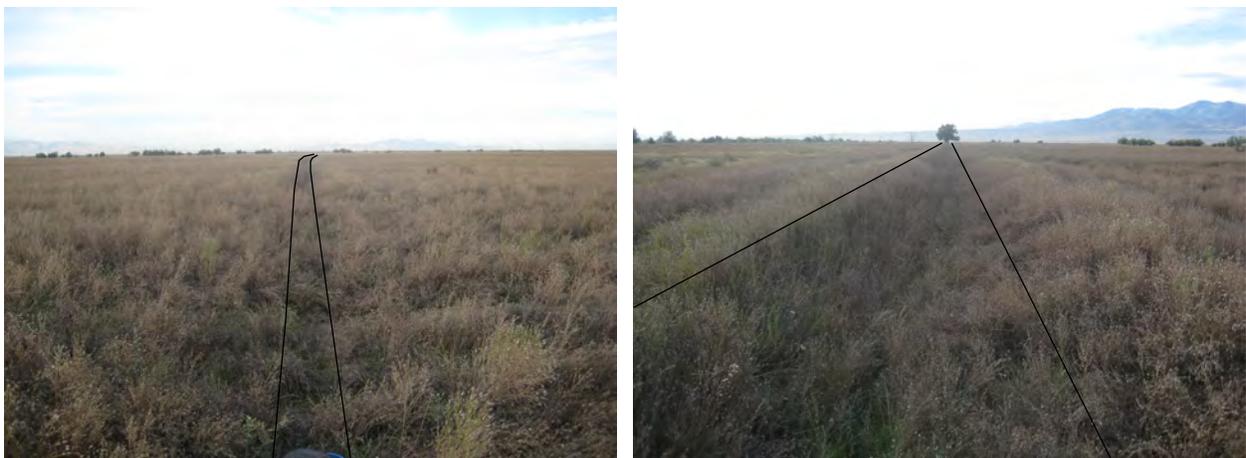
The North Point Consolidated Canal enters the delineation study area midway along the eastern boundary line, flows southwest to the southern boundary line and proceeds west along the southern boundary. The canal historically provided flood irrigation to the delineation study area through a series of feeder ditches constructed in a grid pattern that covers a good portion of the site. These ditches are still evident from aerial photos and are noticeable as one walks across the delineation study area. The flowline of the canal is above the surrounding topography (see photo on page A-74 of Appendix A). Borrow ditches exist adjacent to the canal where material was sourced to help construct the canal banks. A smaller unnamed canal runs along the eastern boundary of the delineation study area entering in the southeast corner of the site and flowing north to the North Point Consolidated Canal.

Photo 2 and Photo 3 - Examples of Feeder Ditches Found within the Delineation Study Area

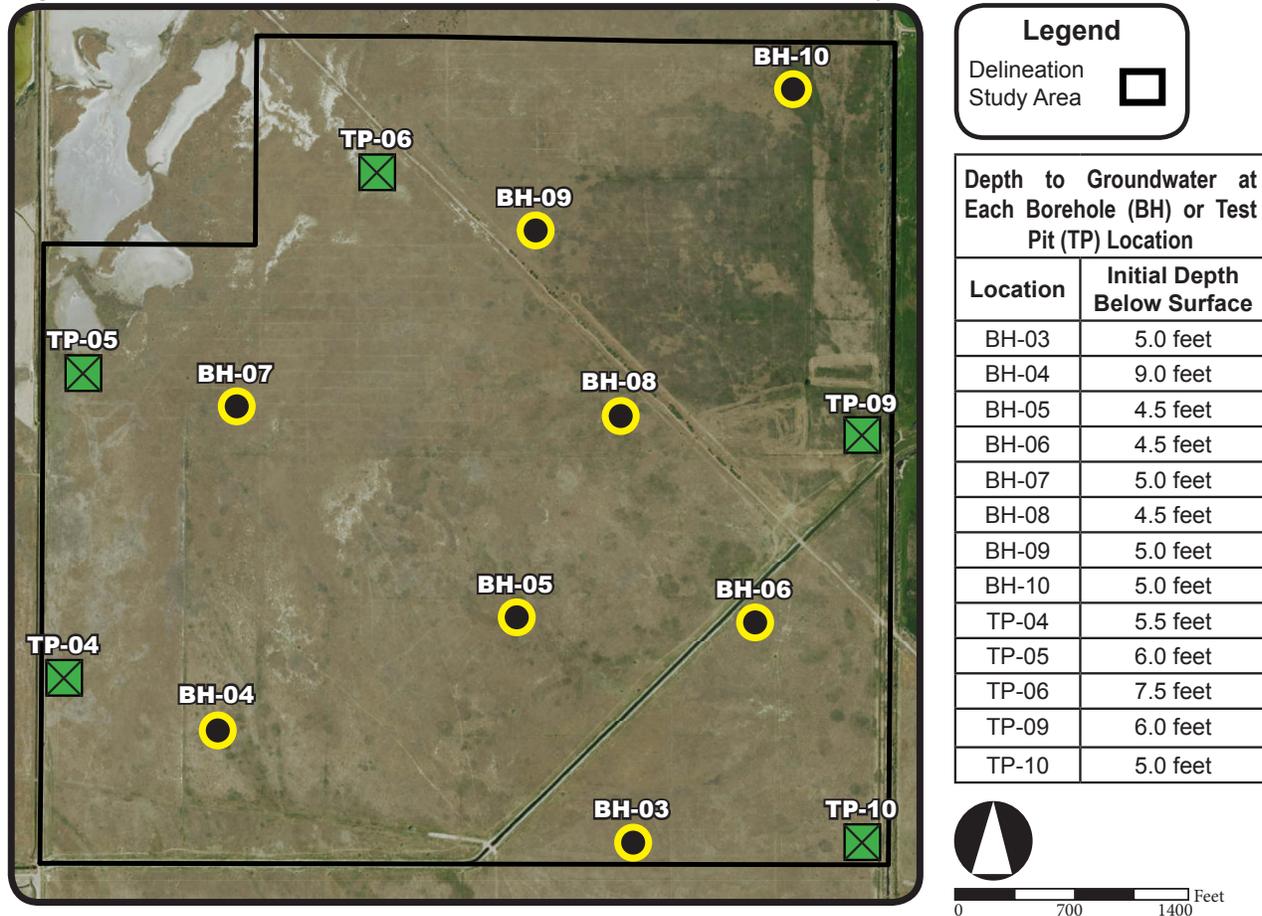
According to the NRCS soil data, the majority of the site has a seasonal high water table between 2.5 and 4.0 feet below the soil surface. Test pits and boreholes taken at several locations across the site by Epic Engineering from April 20 to May 4, 2015 also indicate that there is not a high water table (see Figure 6 for borehole locations and water table depths) (Epic Engineering 2015).

Figure 6 - Borehole and Test Pit Locations within the Delineation Study Area

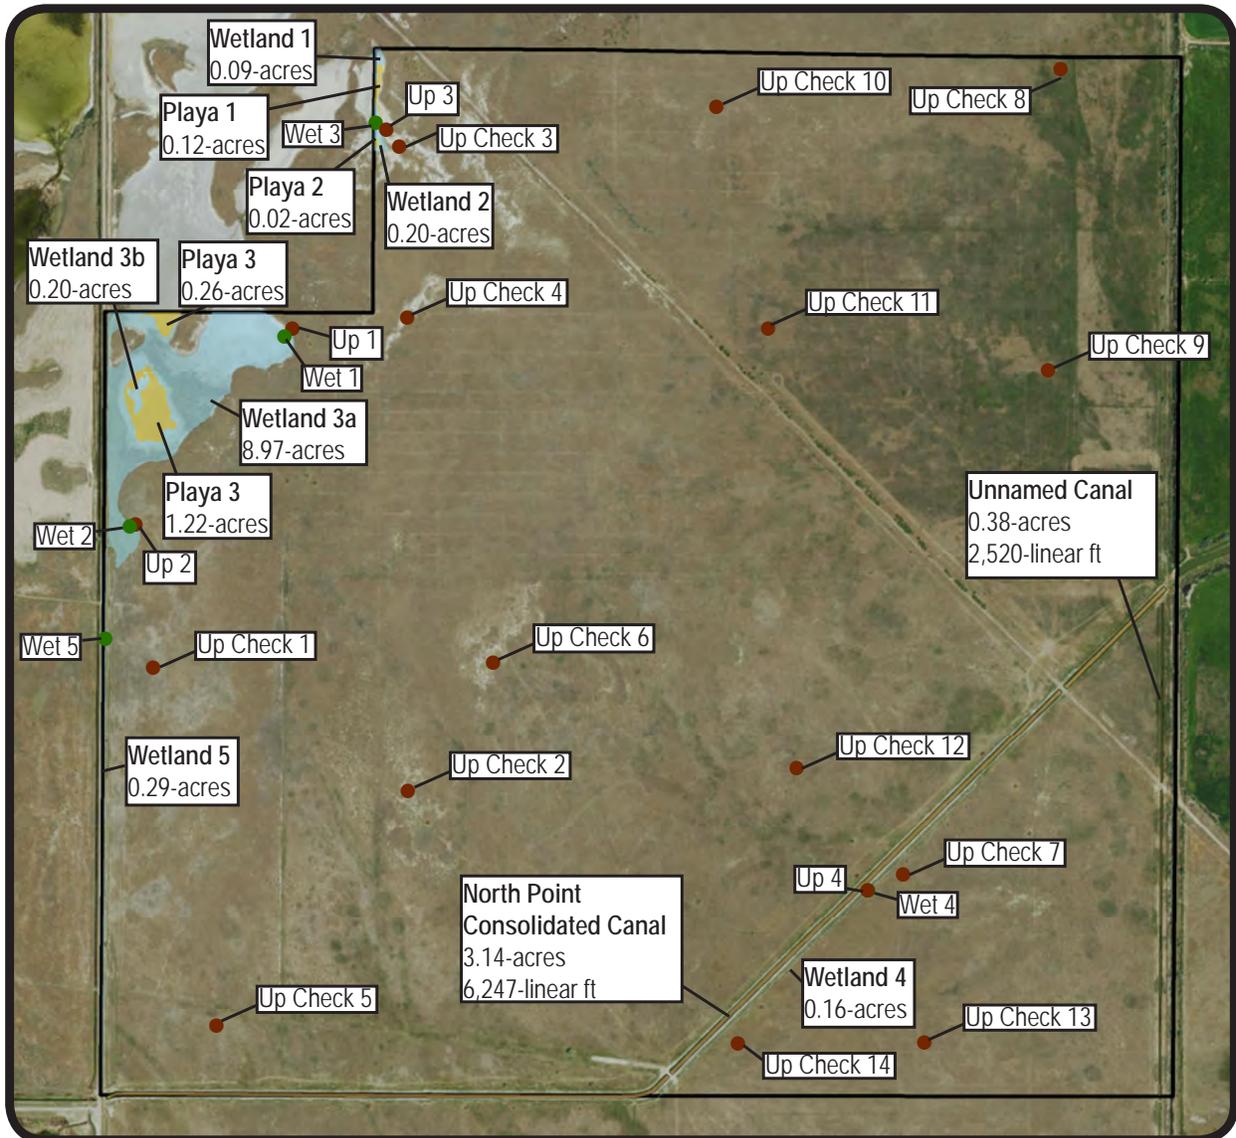
The transition line between wetlands and uplands across the delineation study area occurs mainly as a result of a difference in elevation. Wetlands are typically found in areas where the elevation dropped a few feet from the surrounding upland grade and are mainly adjacent to the playas located in the northwest corner of the site.

Soils examined in the identified wetland areas met the hydric parameters for either a Depleted Matrix (F3), a Sandy Mucky Mineral (S1), or Hydrogen Sulfide (A4). Most wetlands on the delineation study area are located within the Saltair-Playa-Lasil Unit (SPL) occurring in the northwest corner which comprises only 2 percent of the site and is on the National Hydric Soils list. One of the 4 upland paired and none upland check excavated

Figure 7 - Delineation Results

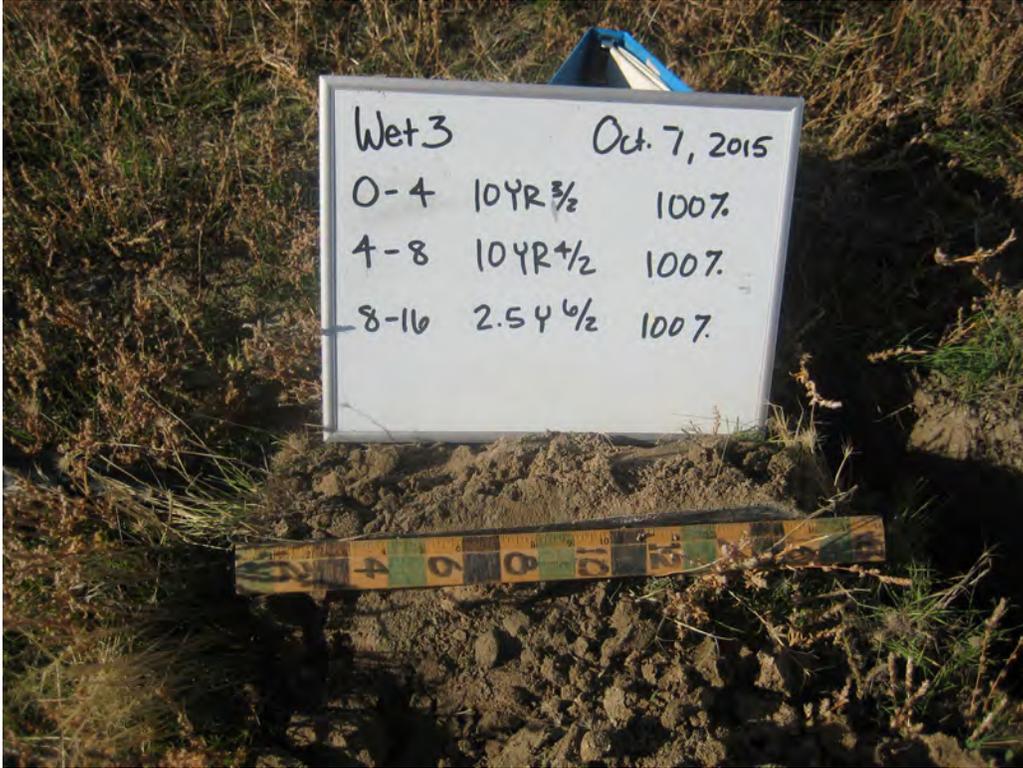
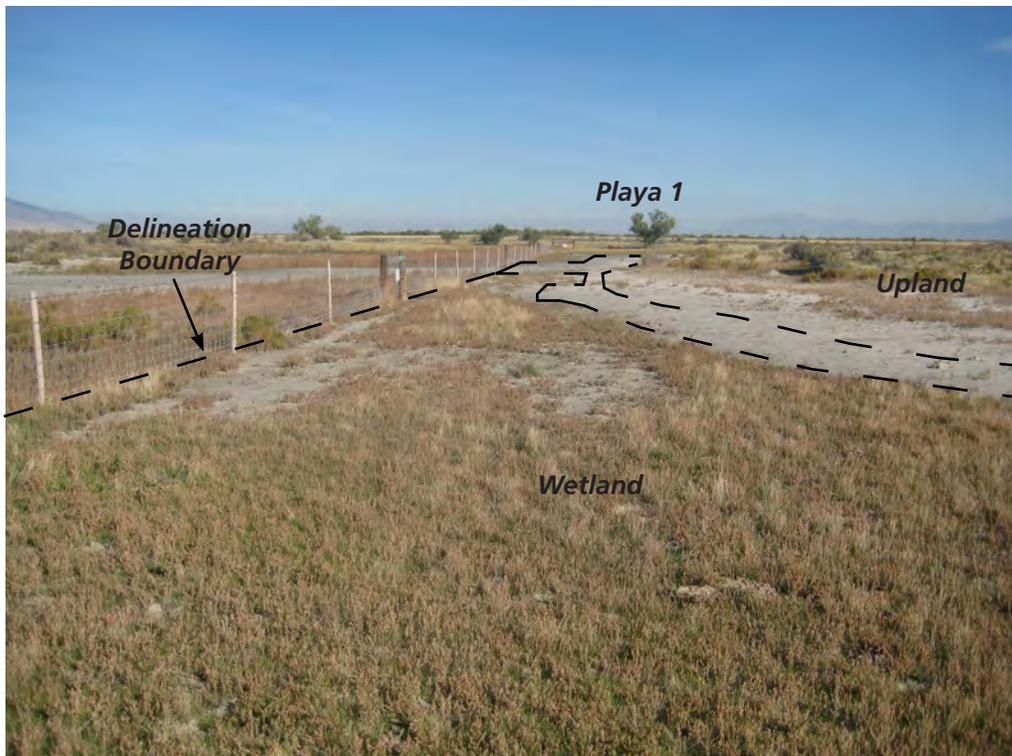
Profile Description: (Describe to the depth needed to document the indicator or confirm the absence of indicators.)								
Depth (inches)	Matrix		Redox Features				Texture ³	Remarks
	Color (moist)	%	Color (moist)	%	Type ¹	Loc ²		
0-4	10YR 3/2	100					Silty clay loam	Soil is damp
4-8	10YR 4/2	100					Silty clay loam	Soil is damp
8-16	2.5Y 6/2	100					Silty clay loam	Cemented layer at 7 inches

Wet 3 – Soil Profile

Wet 3 – General Conditions

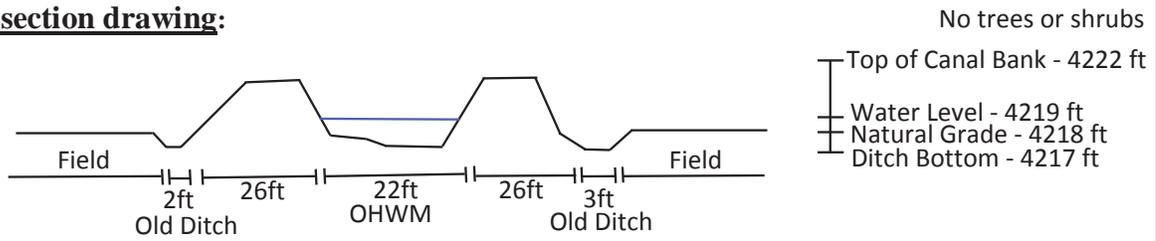
Cross section drawing:

OHWM

No active floodplain.

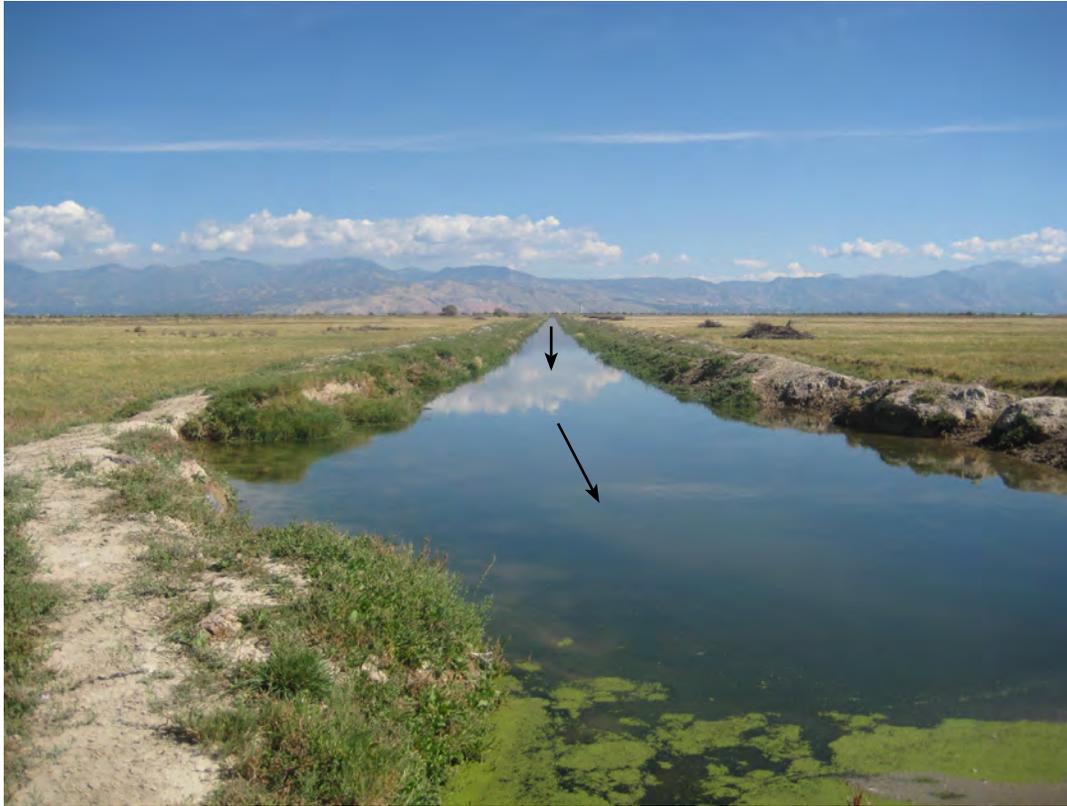
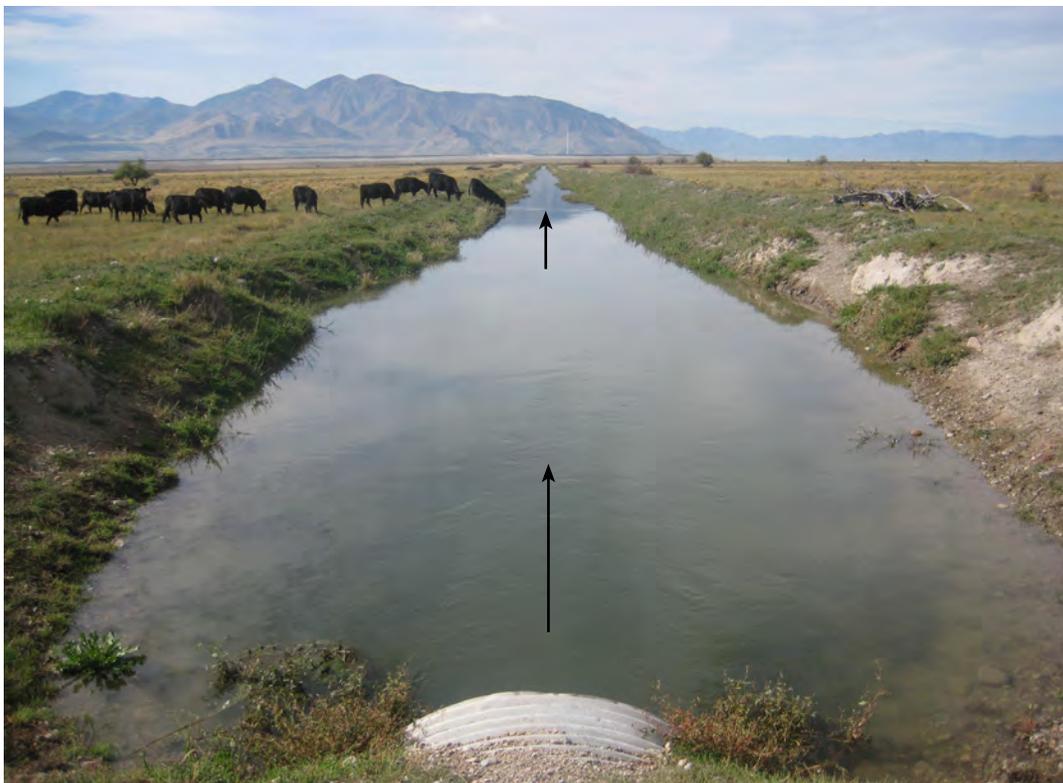
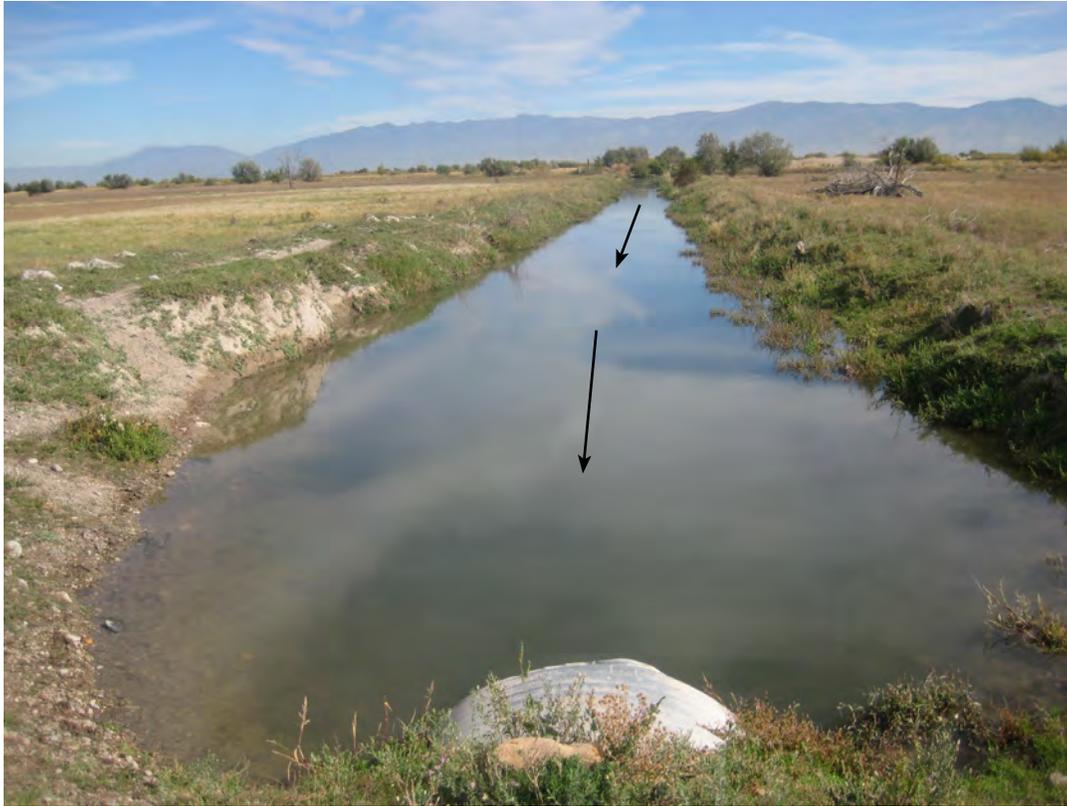
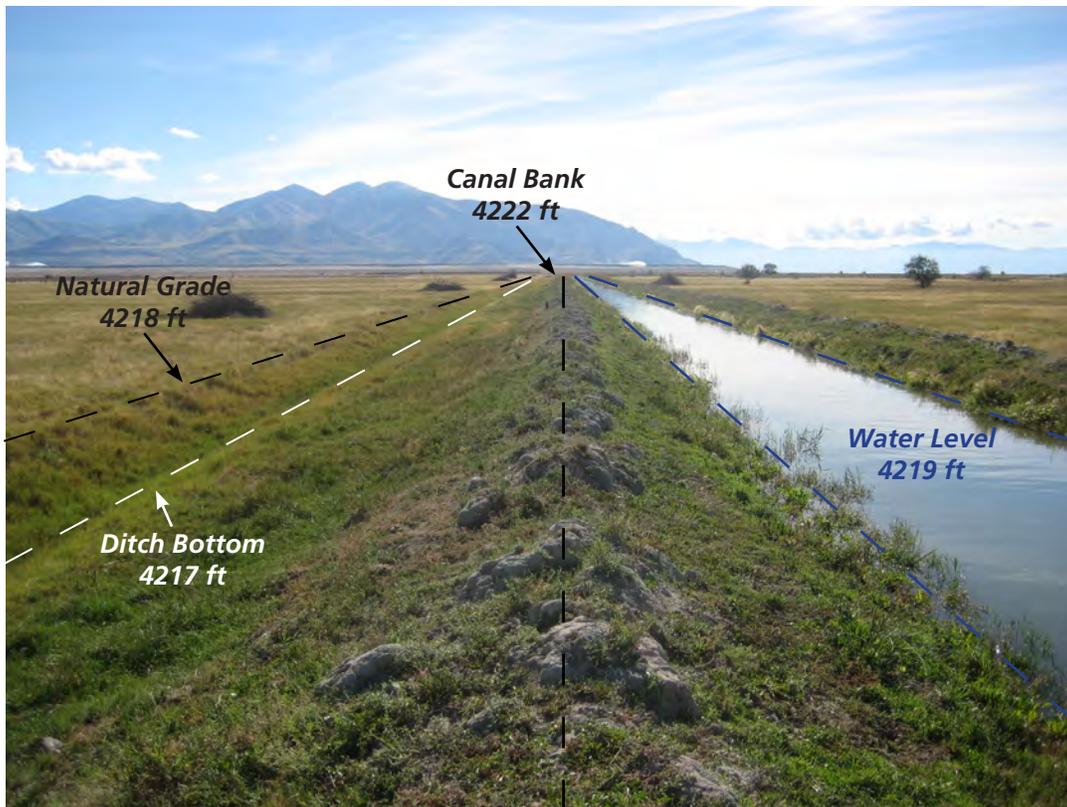
North Point Consolidated Canal – Southwest Corner of Delineation Study Area Looking East

North Point Consolidated Canal - South of Access Road Looking Southwest

North Point Consolidated Canal – North of Access Road Looking Northeast

North Point Consolidated Canal – Water Level and Elevation Changes

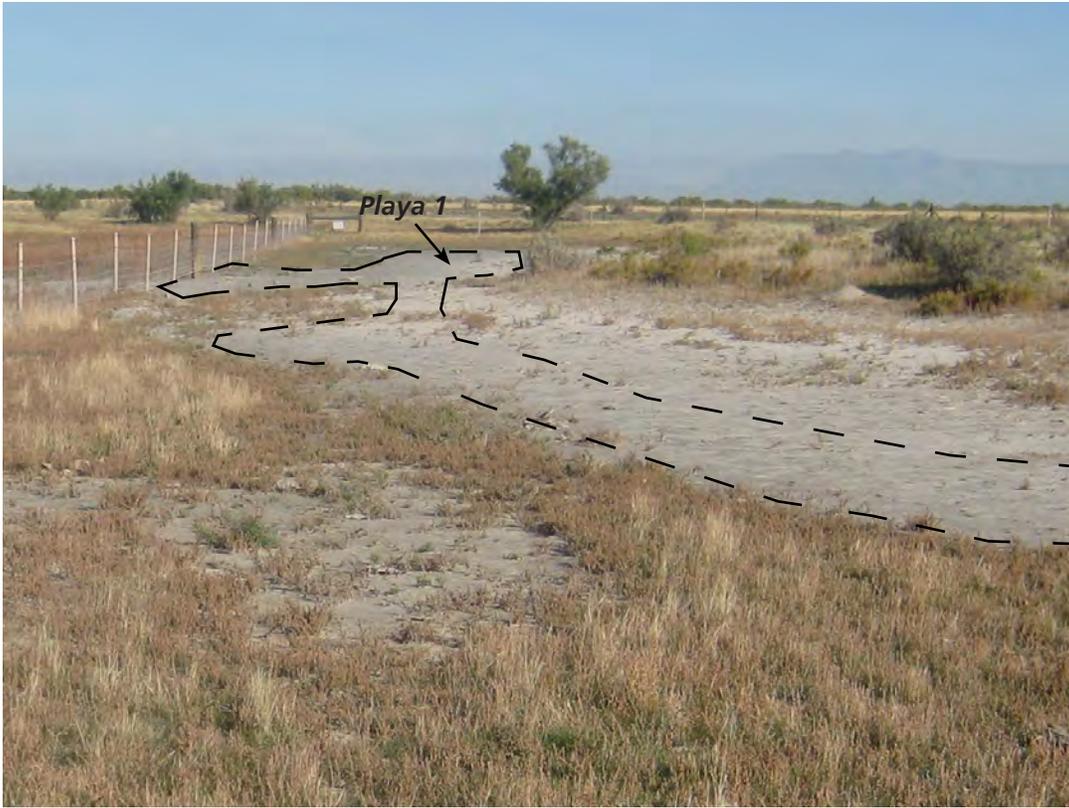
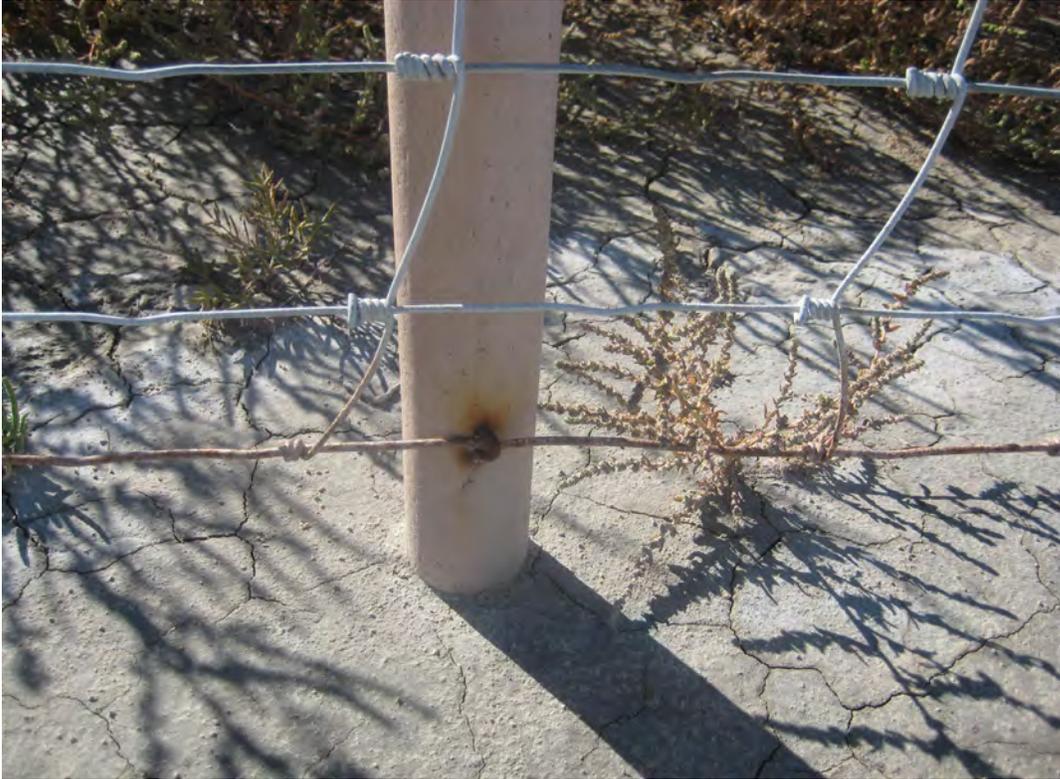
Playa 1 (0.12 acre) and Playa 2 (0.02 acre) are located in the playa complex located in the northwest corner of the property and occurs near or below the 4,213-foot contour. The OHWM indicators that support that this area at least seasonally ponds water include; a change in vegetation species and cover, a break in the bank slope, and water marks in the form of a rusted lower wire on the mesh/barbed wire fencing that runs through the playa. Playa areas below the OHWM that were unvegetated were mapped as playas. The playas have a continuous connection to the Great Salt Lake through wetlands and playas with an OHWM (see Appendix A for OHWM data forms and photos).

Playa 1 - General Conditions

Playa 1 - Evidence of OHWM Rust on Adjacent Fence

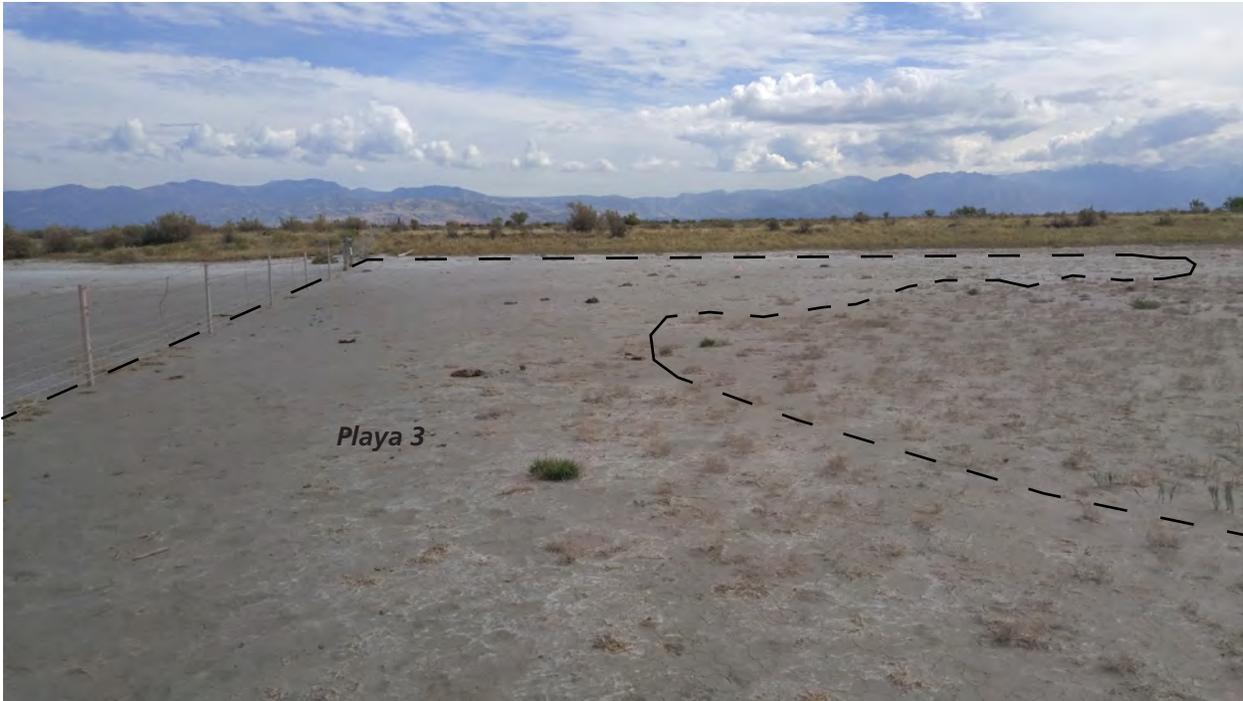
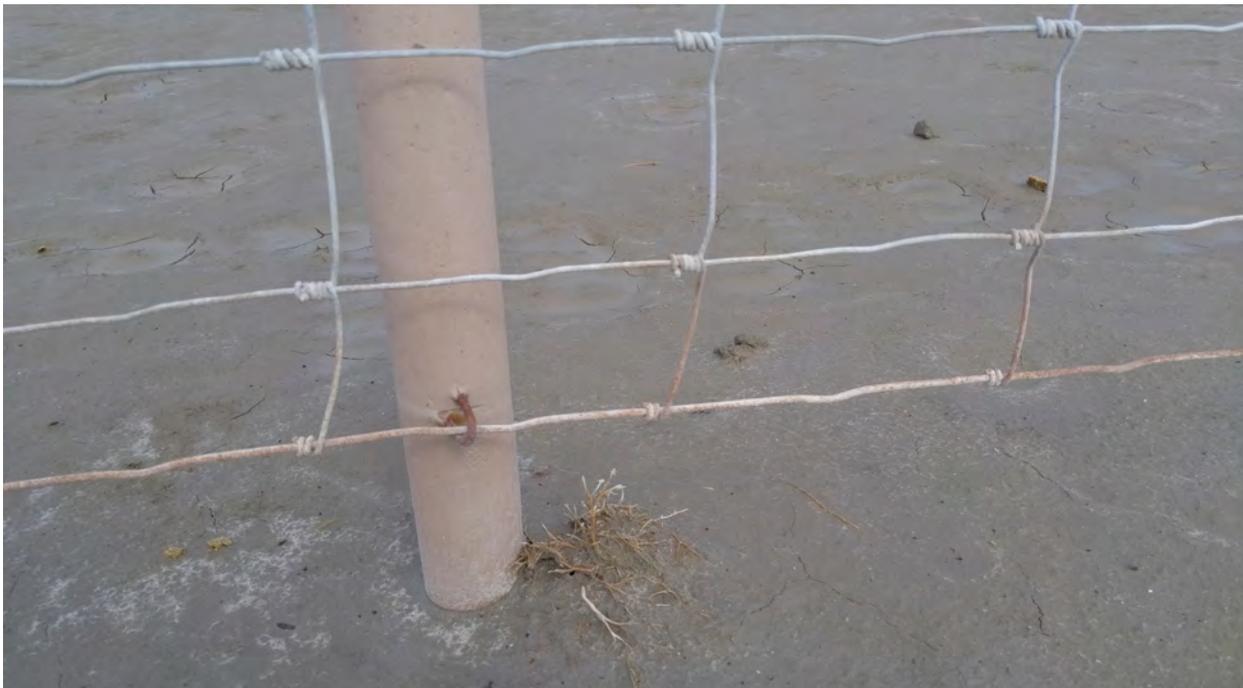
Playa 3 (0.26 acre) is located in the playa complex located in the northwest corner of the property and occurs below the 4,213-foot contour. Playa 3 is part of a much larger playa that extends beyond the delineation study area boundary. The OHWM indicators that support that this area at least seasonally ponds water include; a change in vegetation species and cover, a break in the bank slope, biotic crusts, and water marks in the form of a rusted lower wire on the mesh/barbed wire fencing that runs through the playa. Playa areas below the OHWM that were unvegetated were mapped as playas. The playa has a continuous connection to the Great Salt Lake through wetlands and playas with an OHWM (see Appendix A for OHWM data forms and photos).

Playa 3 - General Conditions

Playa 3 - Evidence of OHWM Rust on Adjacent Fence

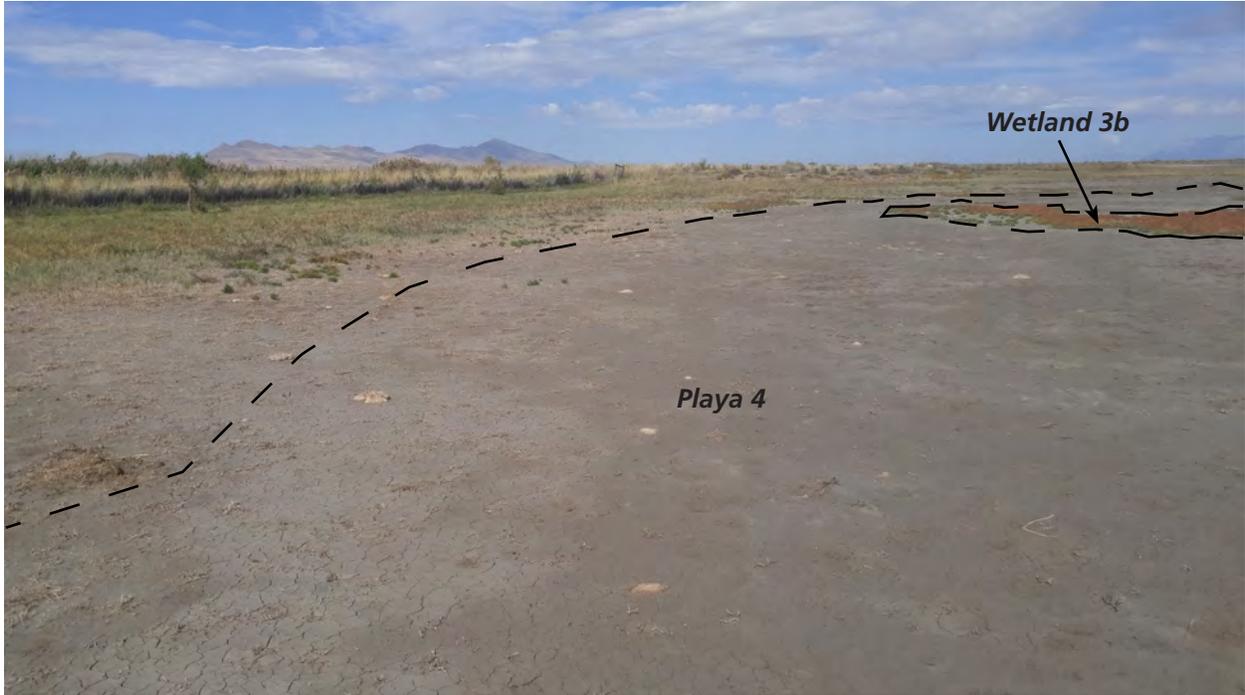
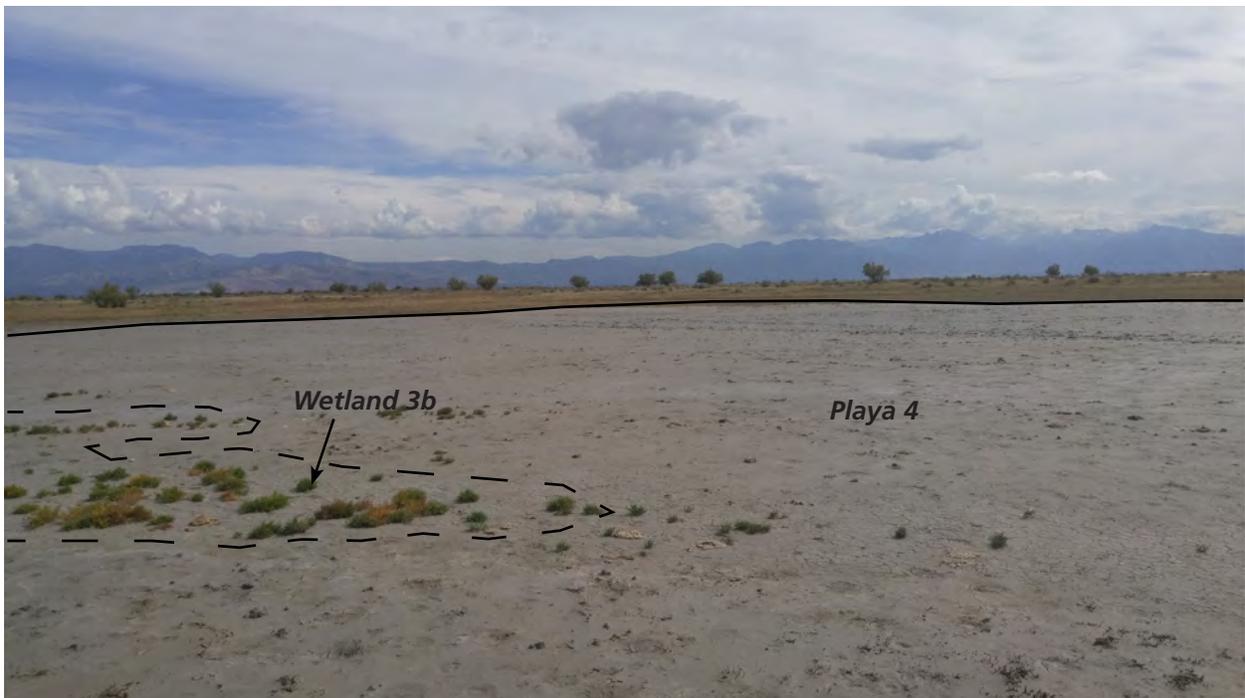
Playa 4 (1.22 acres) is located in the playa complex located in the northwest corner of the property and occurs near 4,213-foot contour. Playa 4 contains Wetland 3b below its OHWM. However, the vegetation within Wetland 3b is greater than 5 percent and was therefore delineated as a wetland. The OHWM indicators that support that this area at least seasonally ponds water include; a change in vegetation species and cover, a break in the bank slope, biotic crusts, and water marks in the form of a rusted lower wire on the mesh/barbed wire fencing that runs near the playa. Playa areas below the OHWM that were unvegetated were mapped as playas. The playa has a continuous connection to the Great Salt Lake through wetlands and playas with an OHWM (see Appendix A for OHWM data forms and photos).

Playa 4 - General Conditions Looking Northwest

Playa 4 - General Conditions Looking Southeast
